Building Surveyors Conference 2016:
Innovative Technologies in Building Surveying
Hong Kong Institute of Surveyors, 15 October 2016

Latest Research and Studies for Water Leakage Detection

Dr. Yu-Leuk CHOI

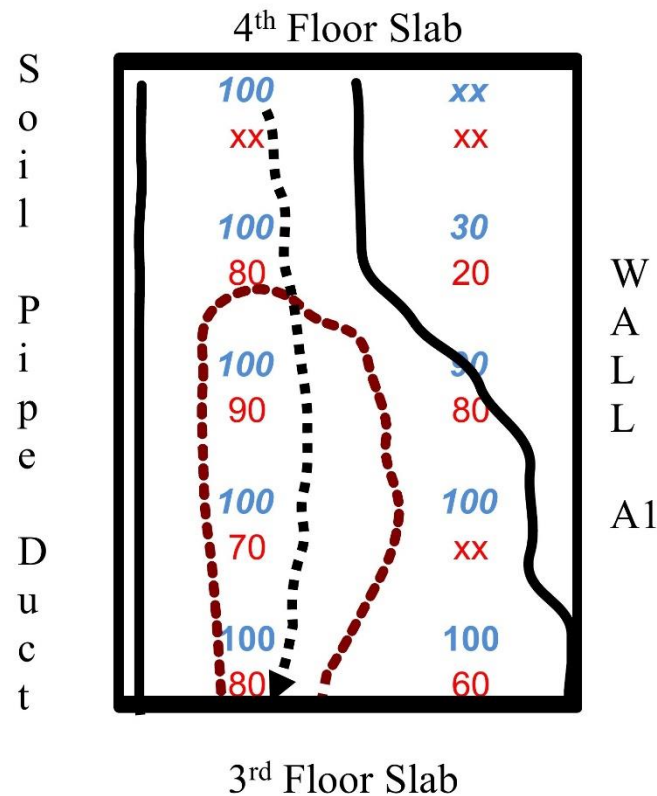
Fig 1. Identifying Flow Path in Wall A1 between 3rd and 4th Floor Slabs

- (a) RC wall A1 separates the toilet on 3rd floor and the rear staircase.
- (b) Moisture contour is derived from Relative Moisture Contents measured at 80mm from the interior face (in the toilet)
- (c) Portable Roof and Wall Moisture Scanner RWS manufactured by Tramex Ltd, Shankill Co. Dublin, Ireland was used.
- (d) Sensitivity scale was set at 2.1.

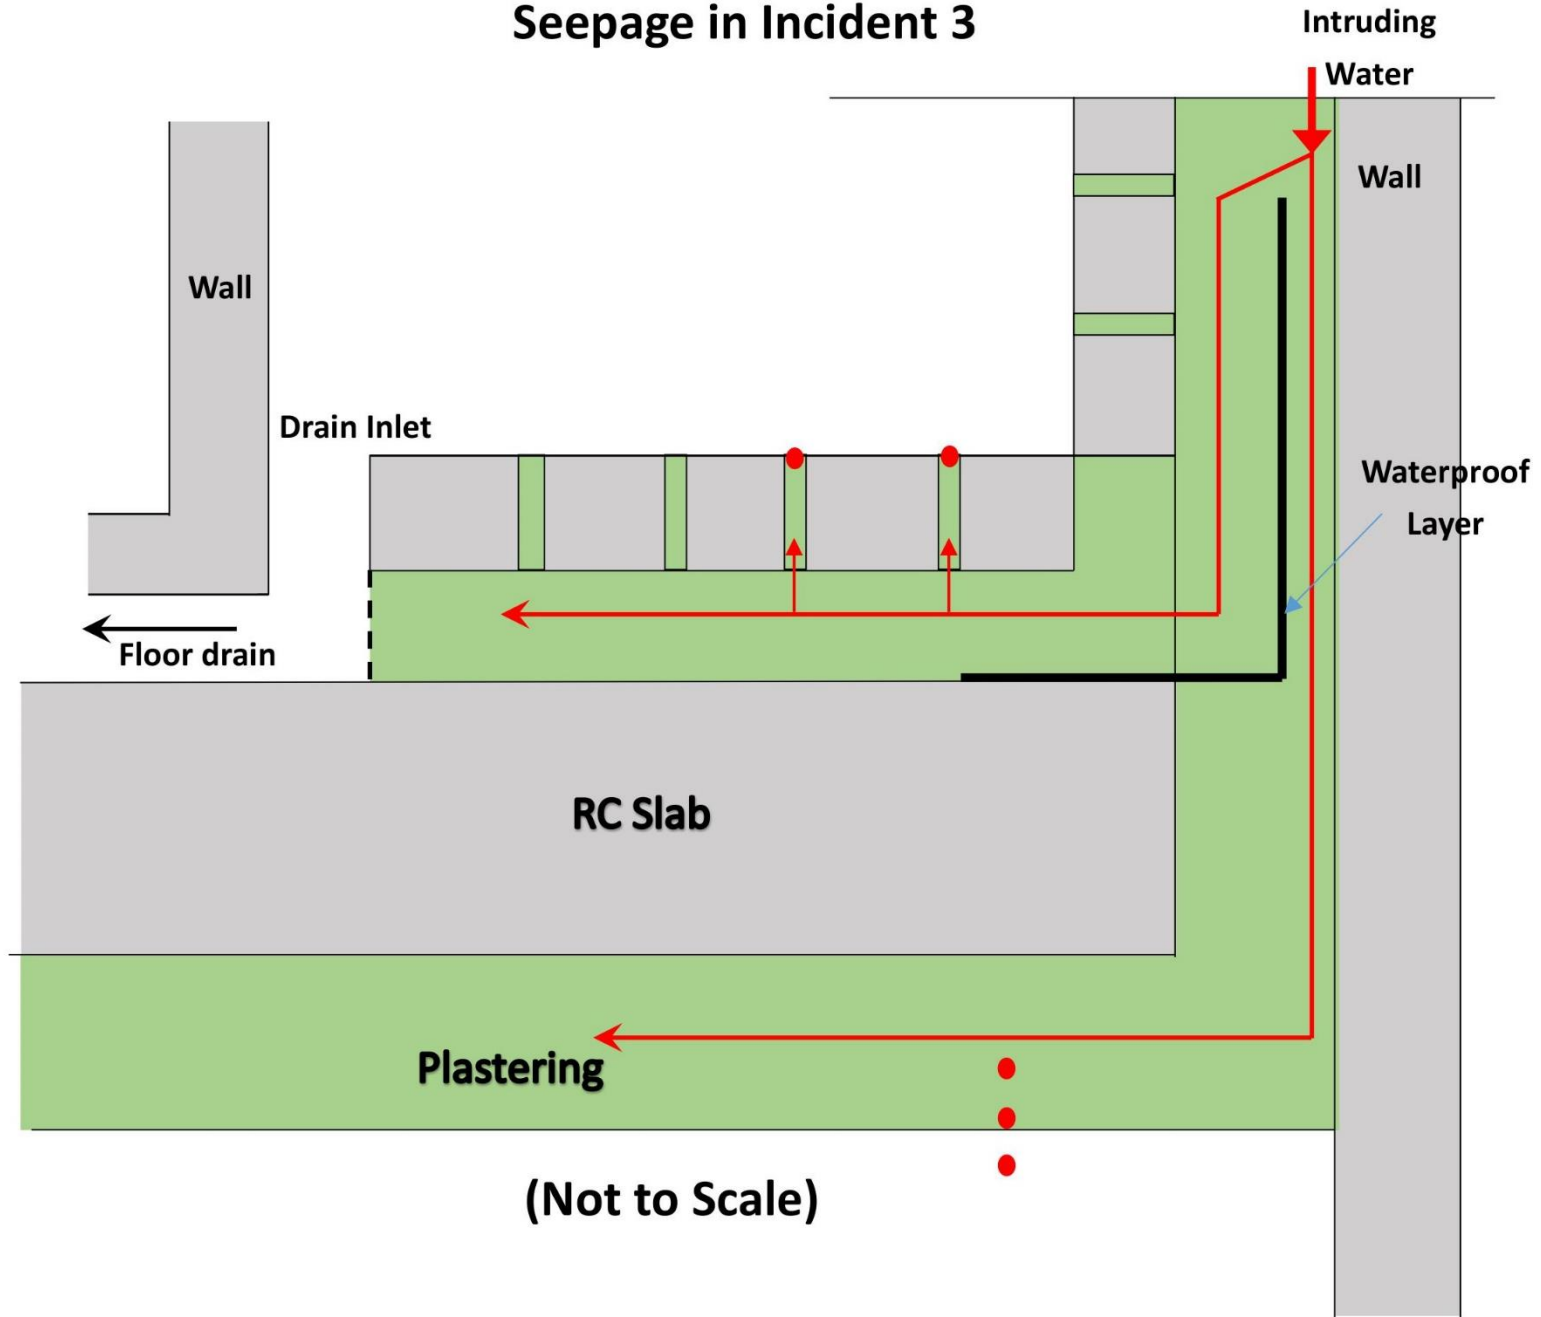
Seepage in Incident 3

- 3 seepage incidents at same location.
- 2 PT conducted during each of Incidents 1 and 2. One positive and one negative in each set of results.
- During 3rd Incident, vertical inflow was found to exist and intruded both upper and lower side of floor slab.
- Diffusion had caused the anomaly. Demonstrated by experiment.

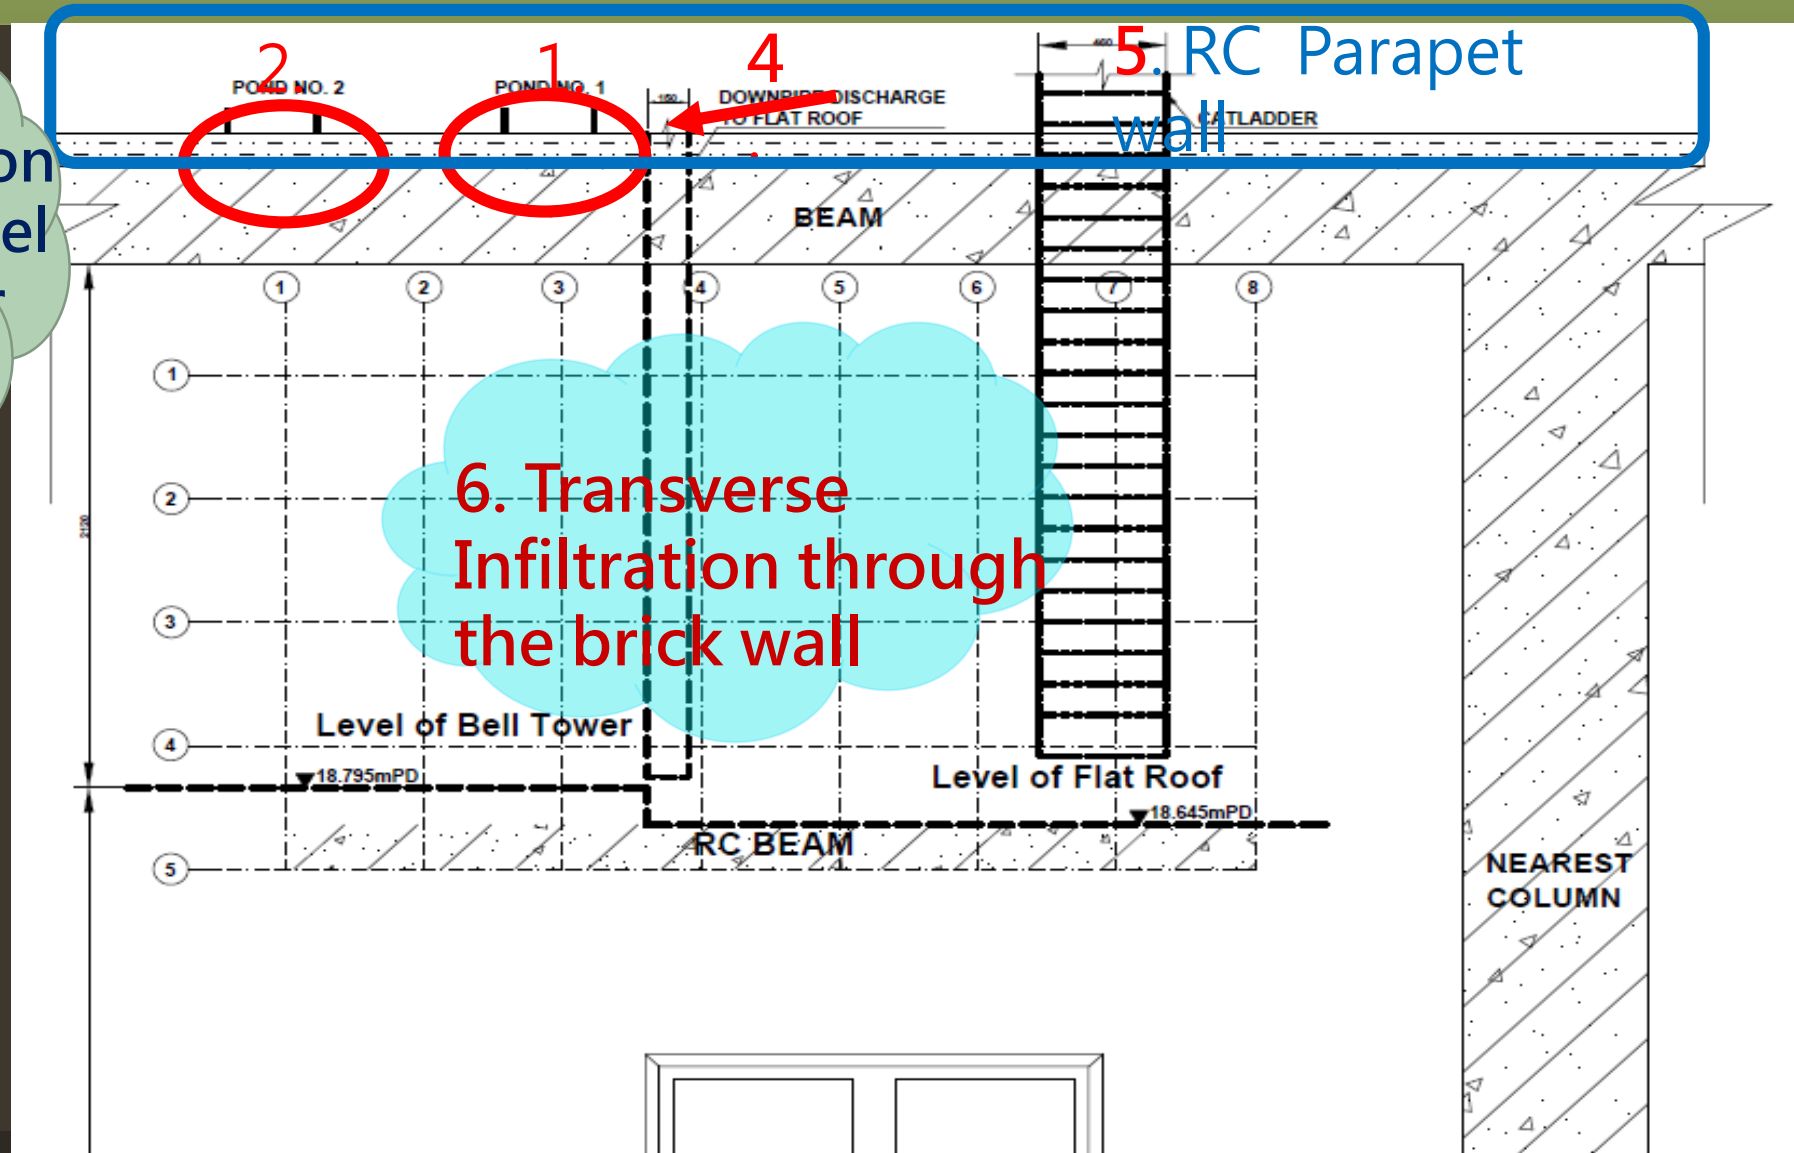
6 suspected Water Ingress Points were water sprayed on 17/4/2015

3. Crack 3 on roof channel not further tested.

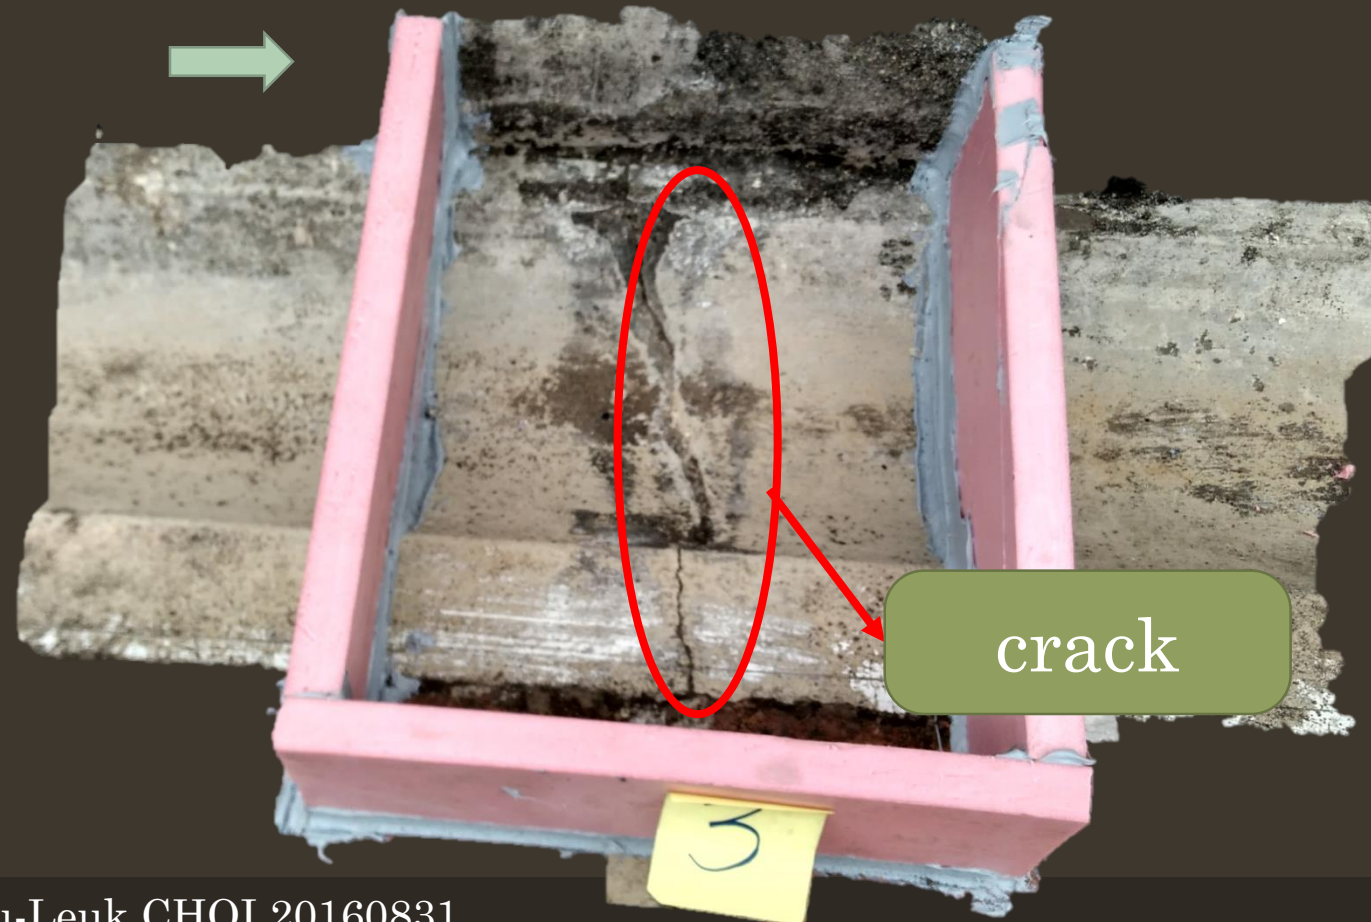
3 cracks observed in roof channel

- Ponding tests to check leakage by measuring change in water level
- Result : Pond 3 had no leakage

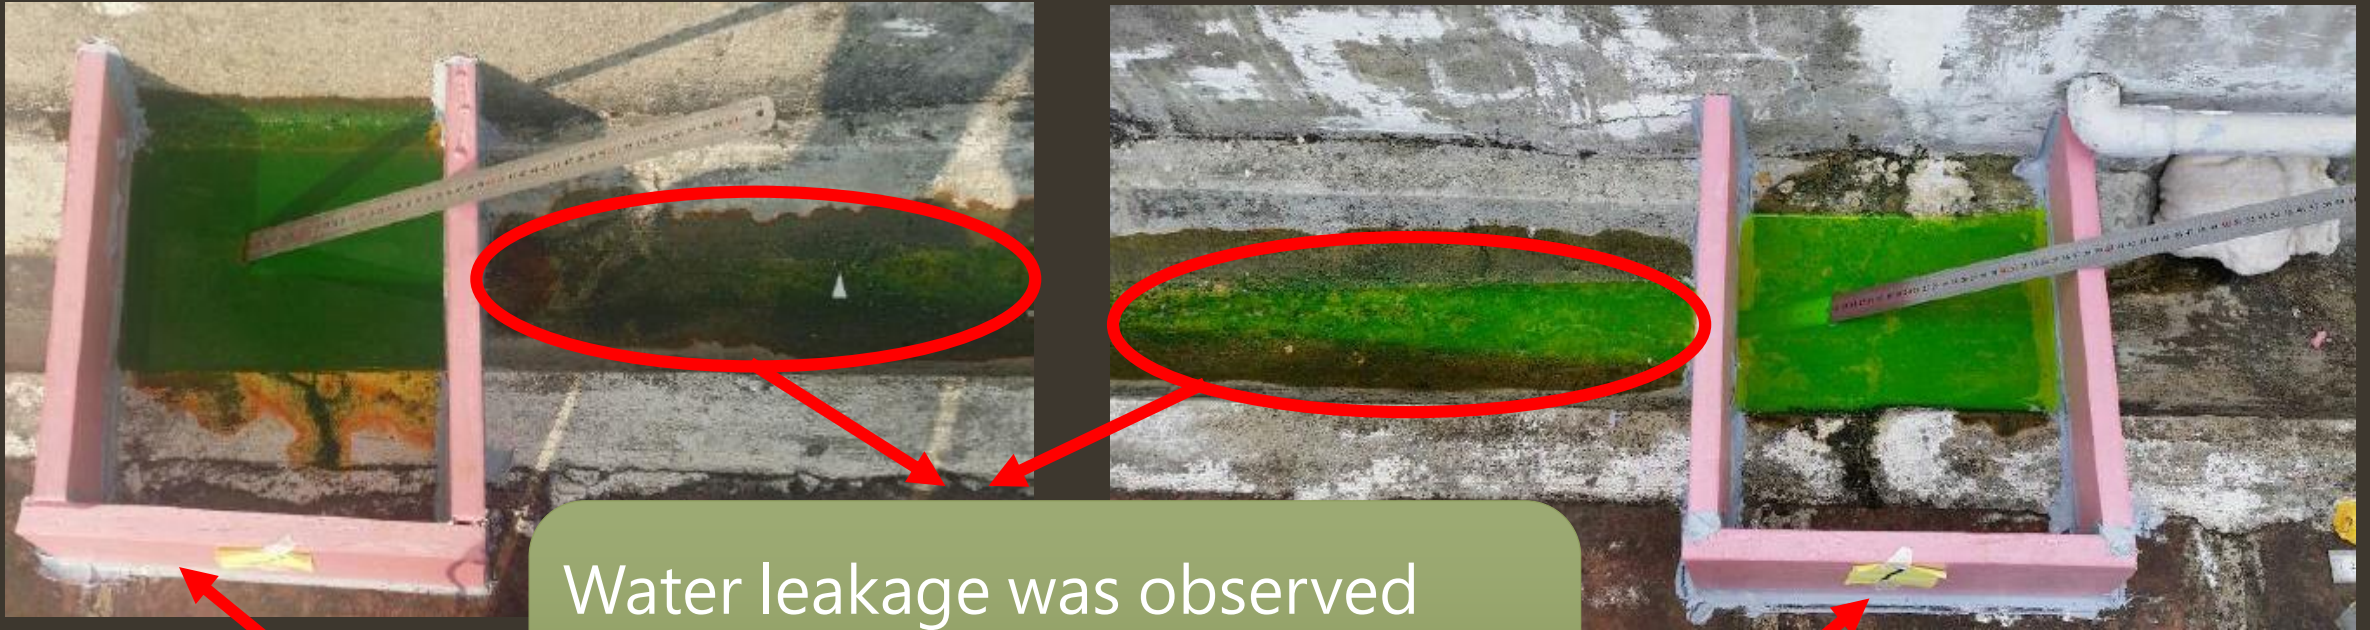
Remaining 2 cracks at Ponds 1 and 2 are **inter-connected**

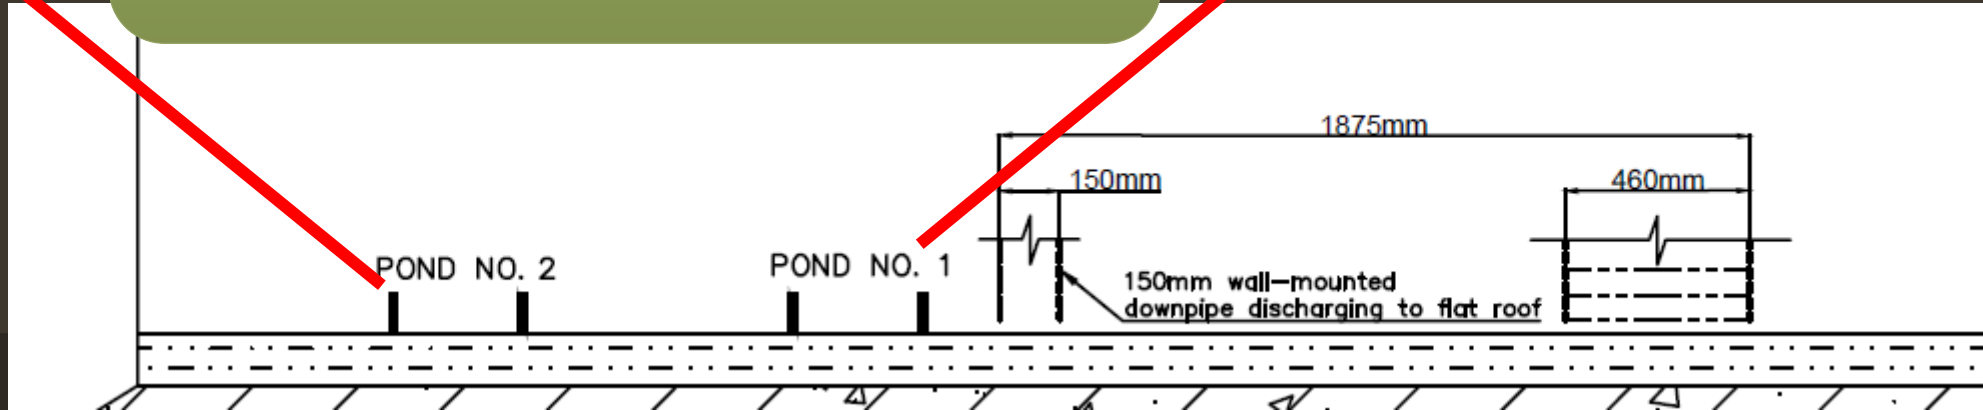
Water leakage was observed between two ponds after 10 minutes from start of both ponds

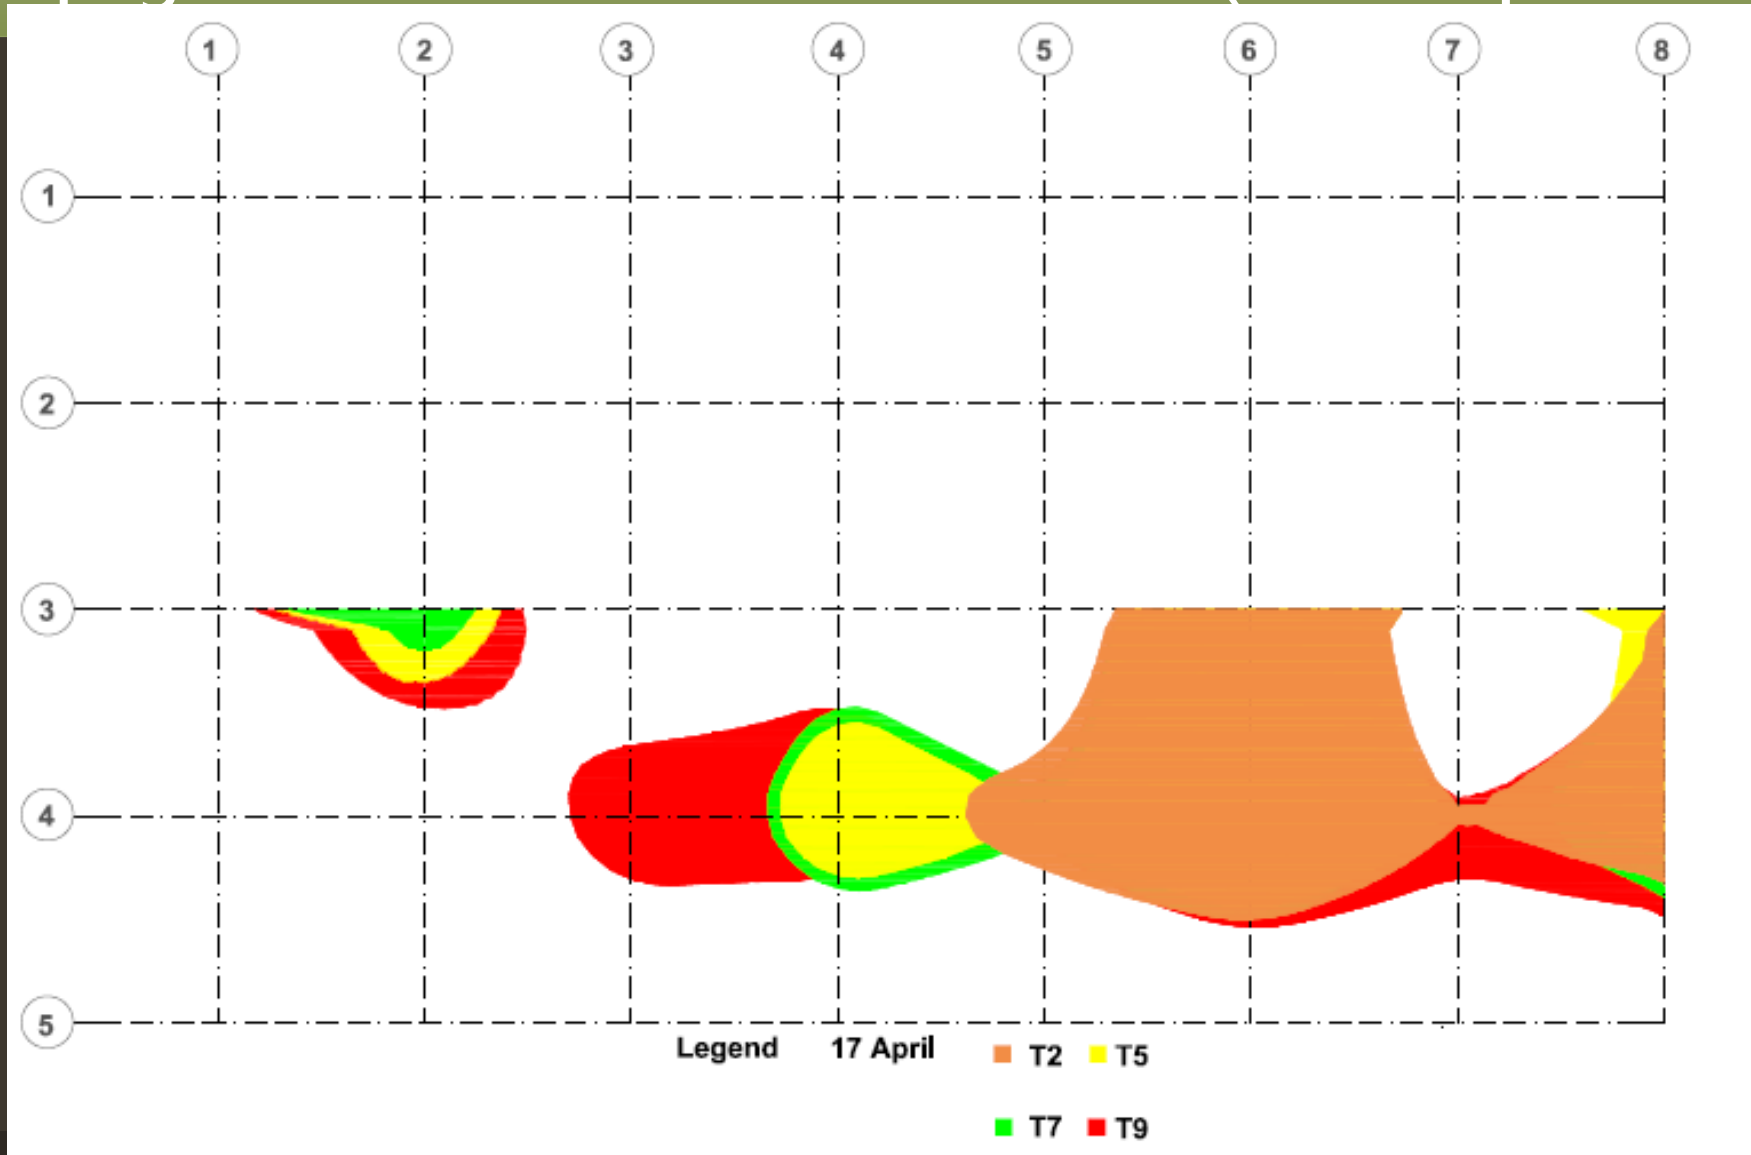
Propagation of 35-contours with time (on 17 April 2015)

Part of Wall remained dry

Horizontal flow at Y4 level

- 3 separate streams
- Rate of descent of 80 contour $\sim 1 \text{ cm/h} \sim 2.8 \times 10^{-3} \text{ mm/s}$
- Compare with concrete permeability of 10^{-5} . Hence flow turns horizontal above RC beam.
- Time to descend from Y1 to Y3 $\sim 1 \text{ m} / (1\text{cm/h}) \sim 100 \text{ h} = 4.2 \text{ days}$. Hence flow below Y3 on 17/4/2015 is from wall infiltration only.
- Validated by subsequent **ponding-scanning test** on 16/6/2015

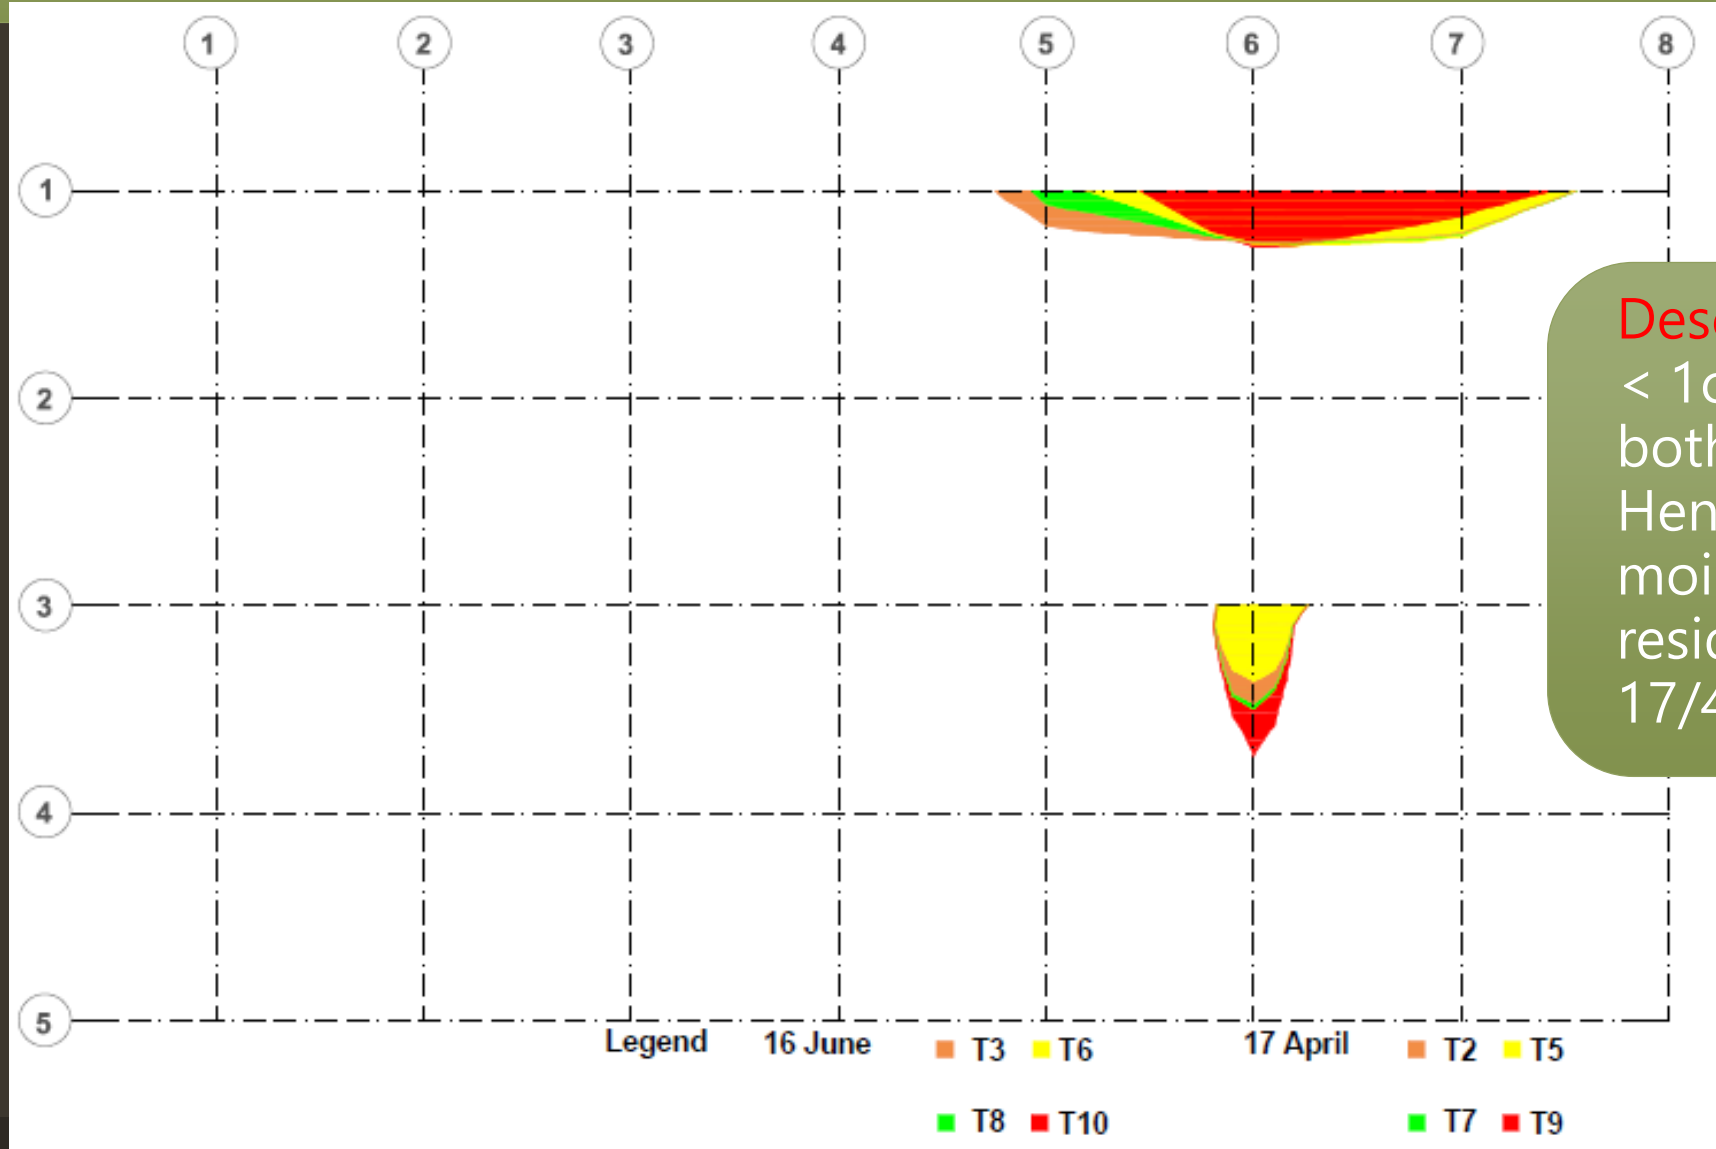
Propagation of 80-contours with time (from both tests)

Descending Flow
< 1 cm /hr,
both dates.
Hence, lower
moisture patch is
residual from
17/4/15

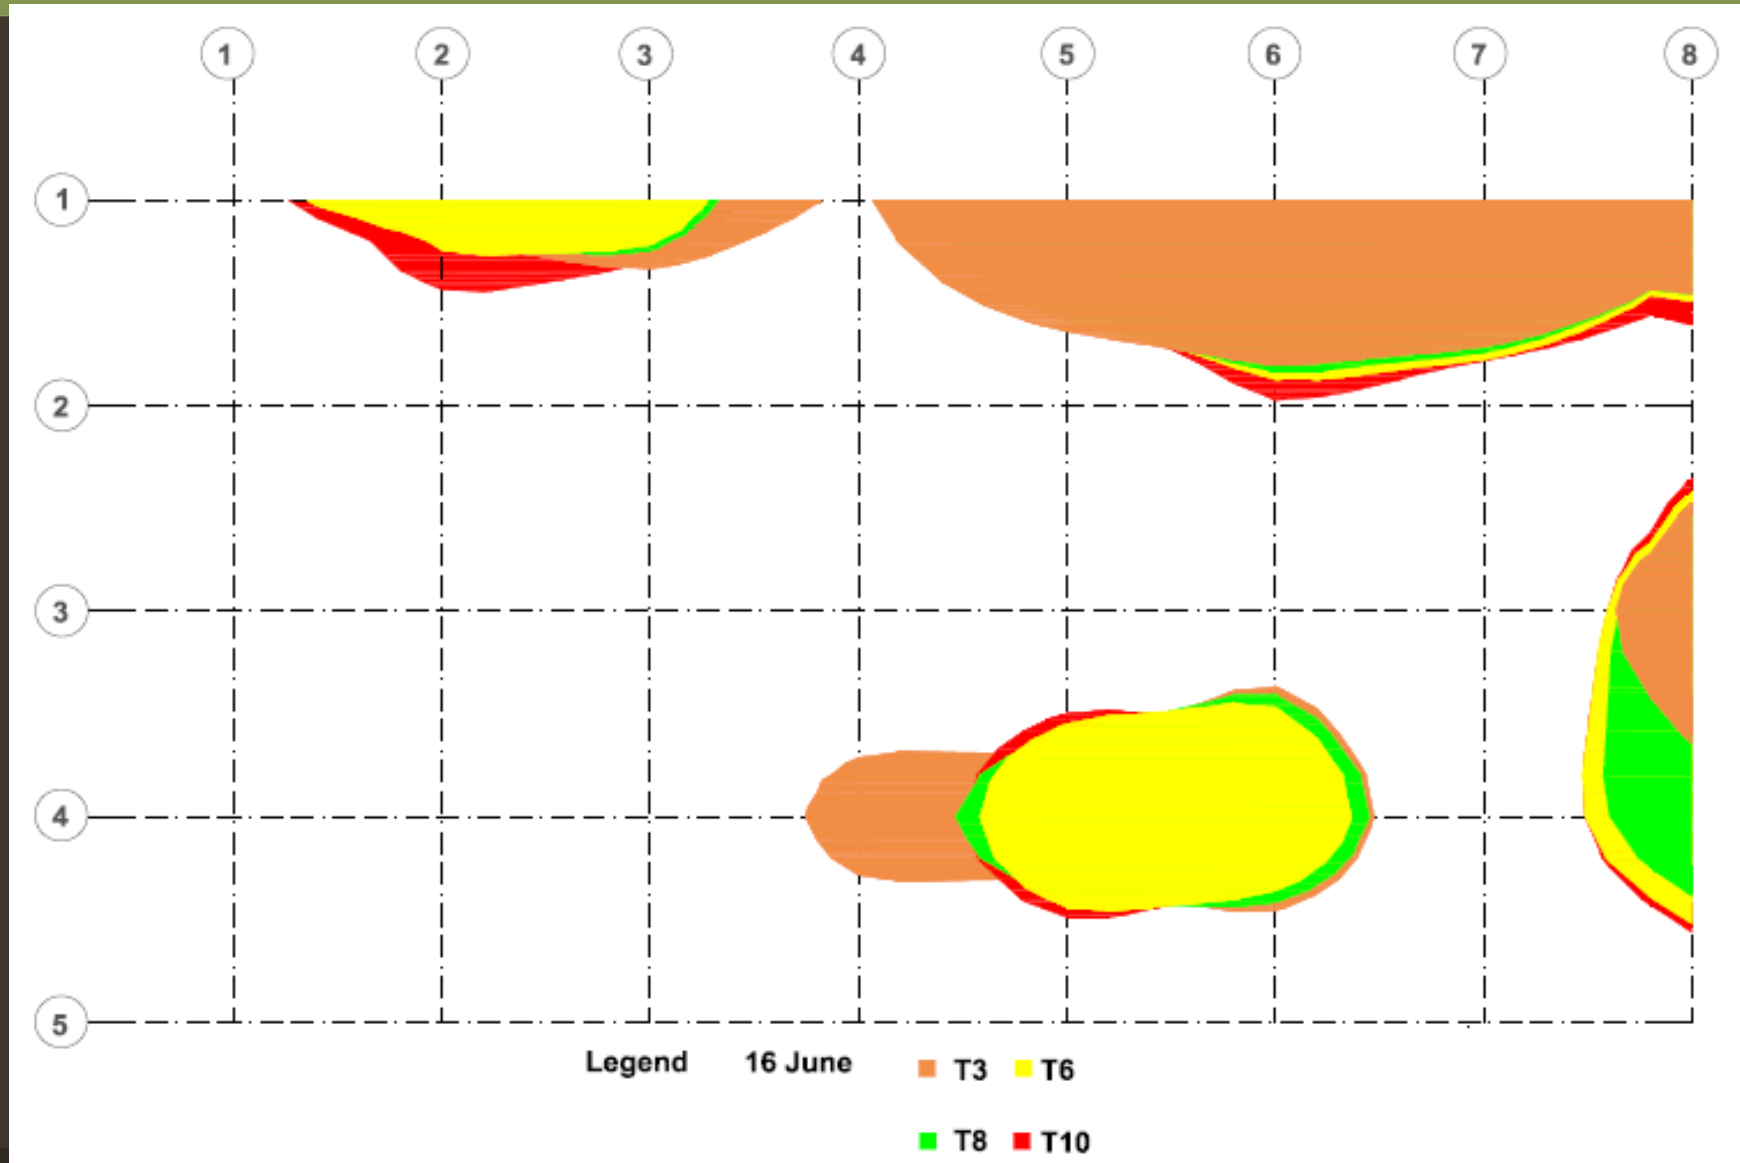
Propagation of 35-contours with time (on 16 June 2015)

Part of
Wall
remain
ed dry.

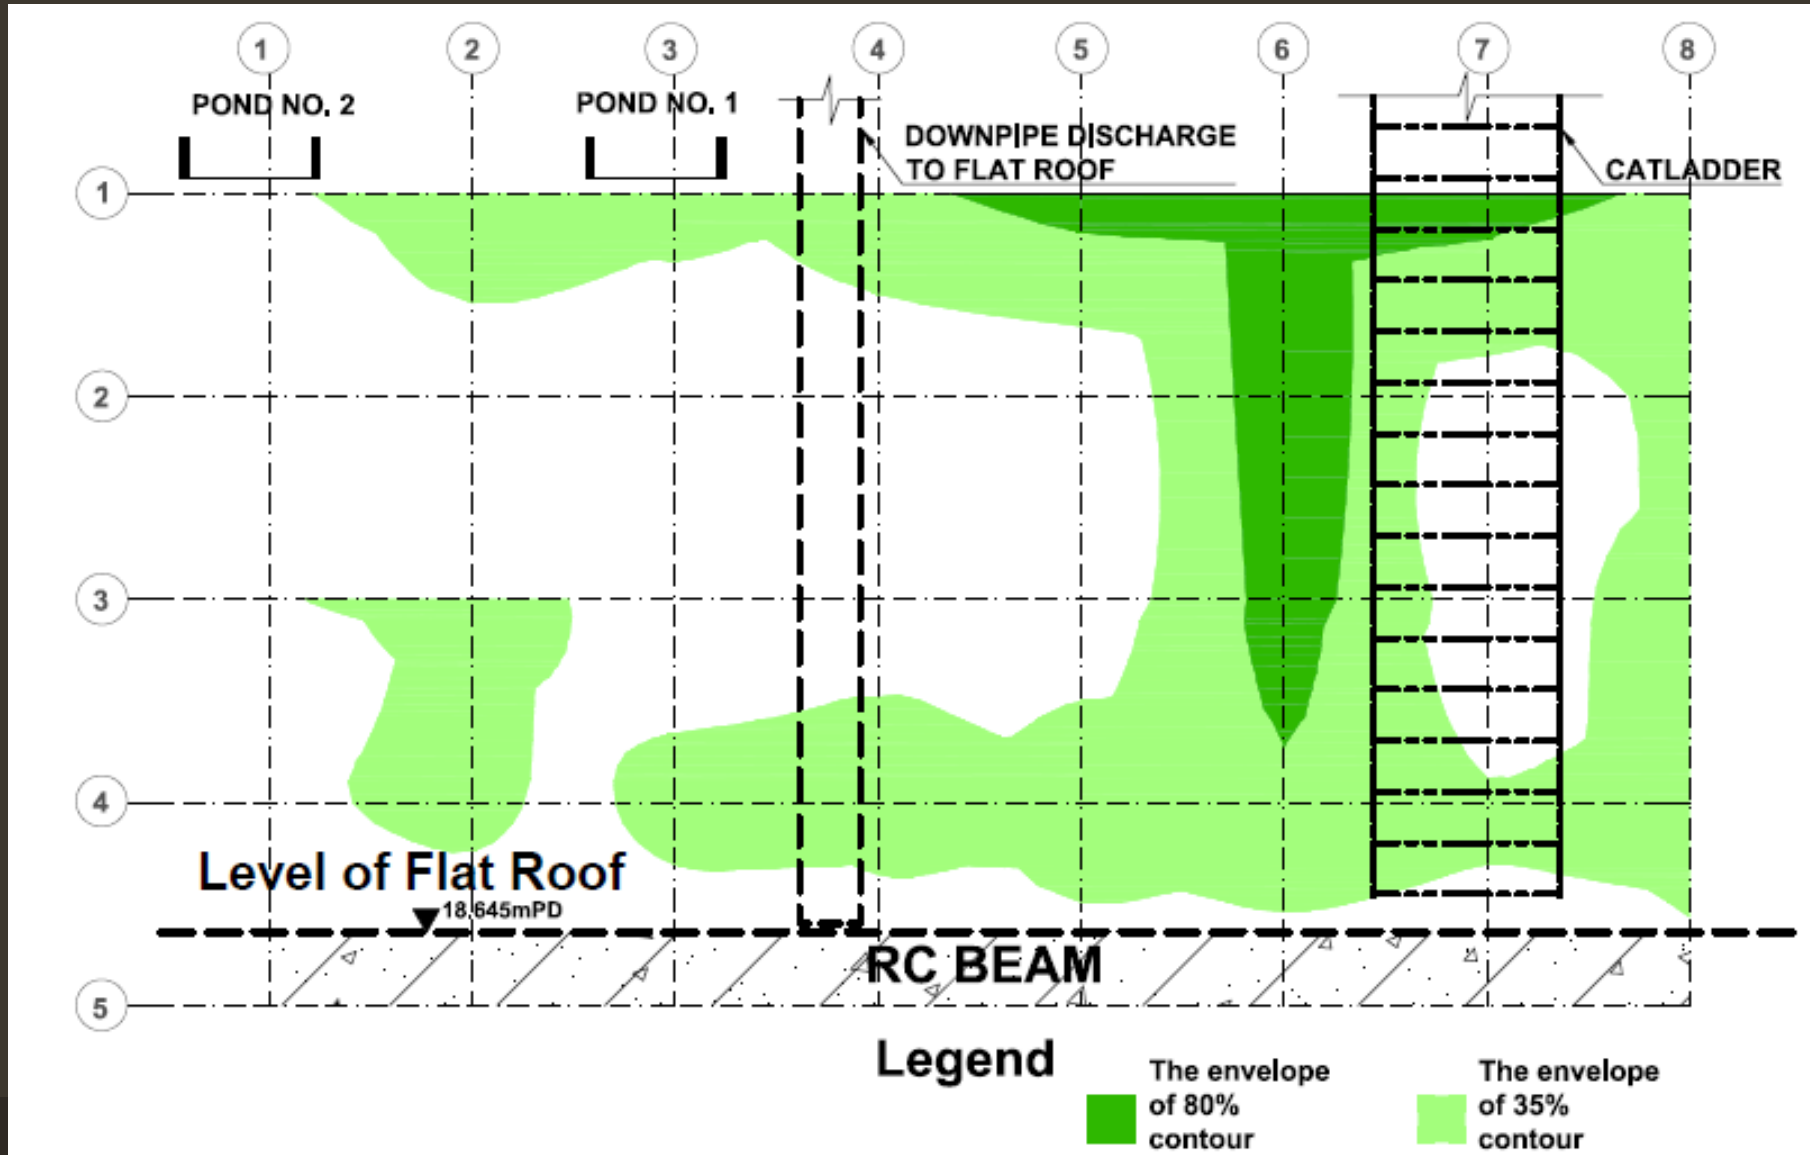
Flow Field in Wall : reflection of permeability

1. RC is effectively impermeable
2. Wall dampness is caused by infiltration from the external face as well as from cracks on the roof channel.
3. Corollary : Surface water-proofing layer is an effective means of preventing seepage in brick wall.

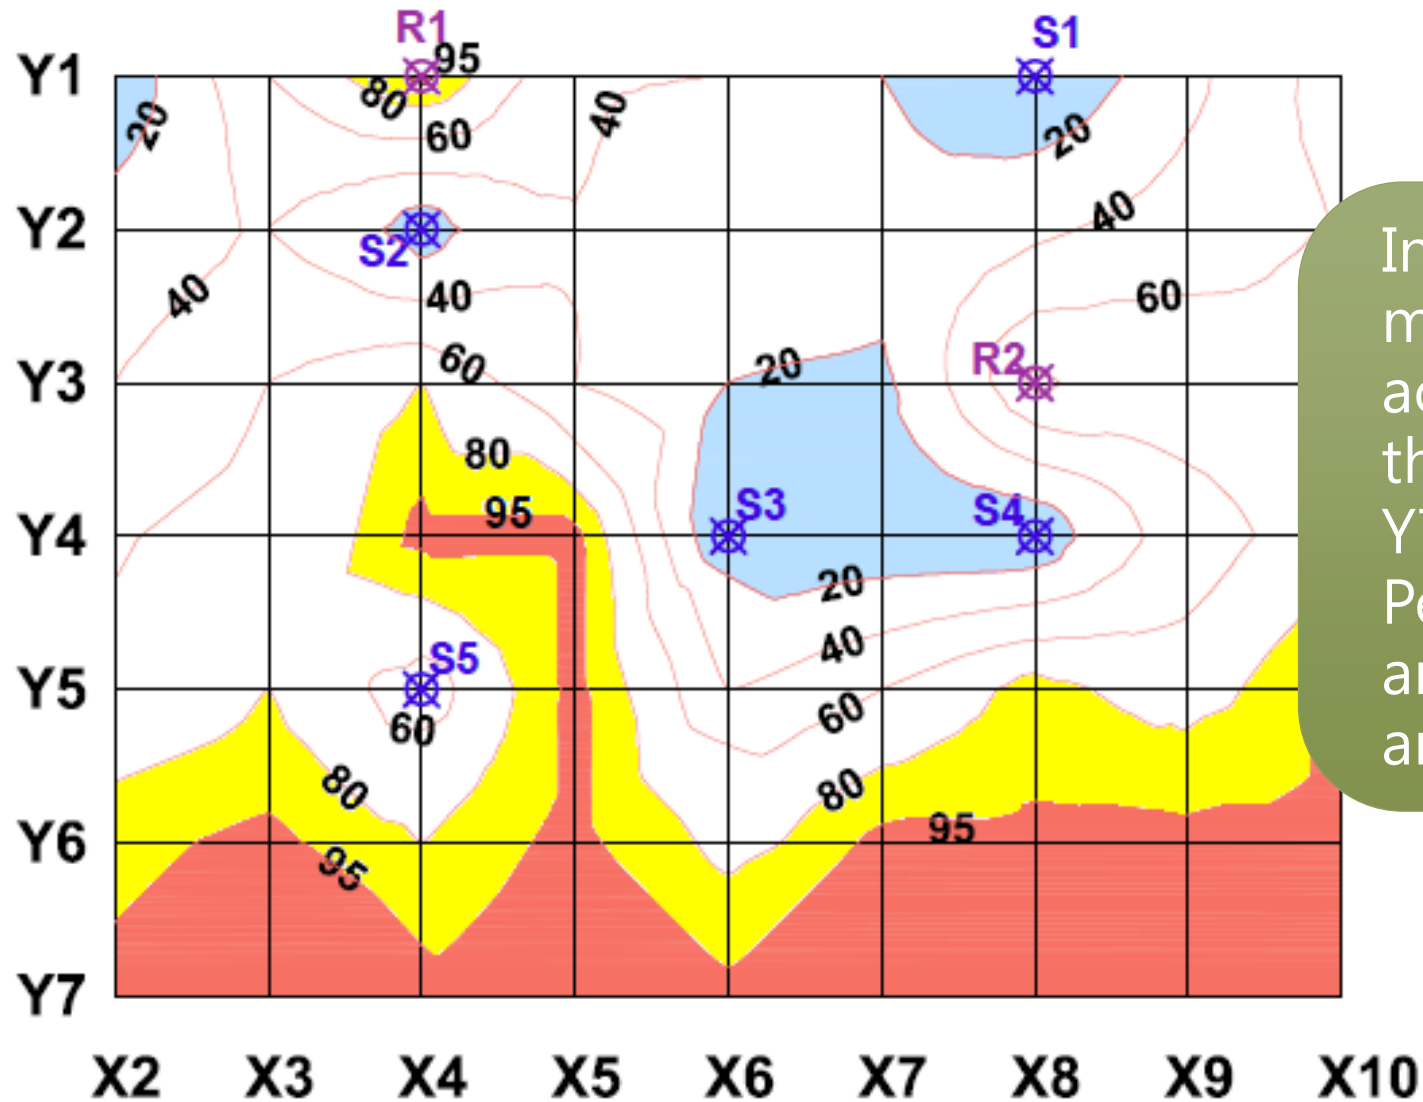
Moisture Contours Map for PT Room on 17/3/2015

In lower side, moisture is accentuated along the **dampest** line Y7.

Peaks and troughs are possible inflow and outflow points

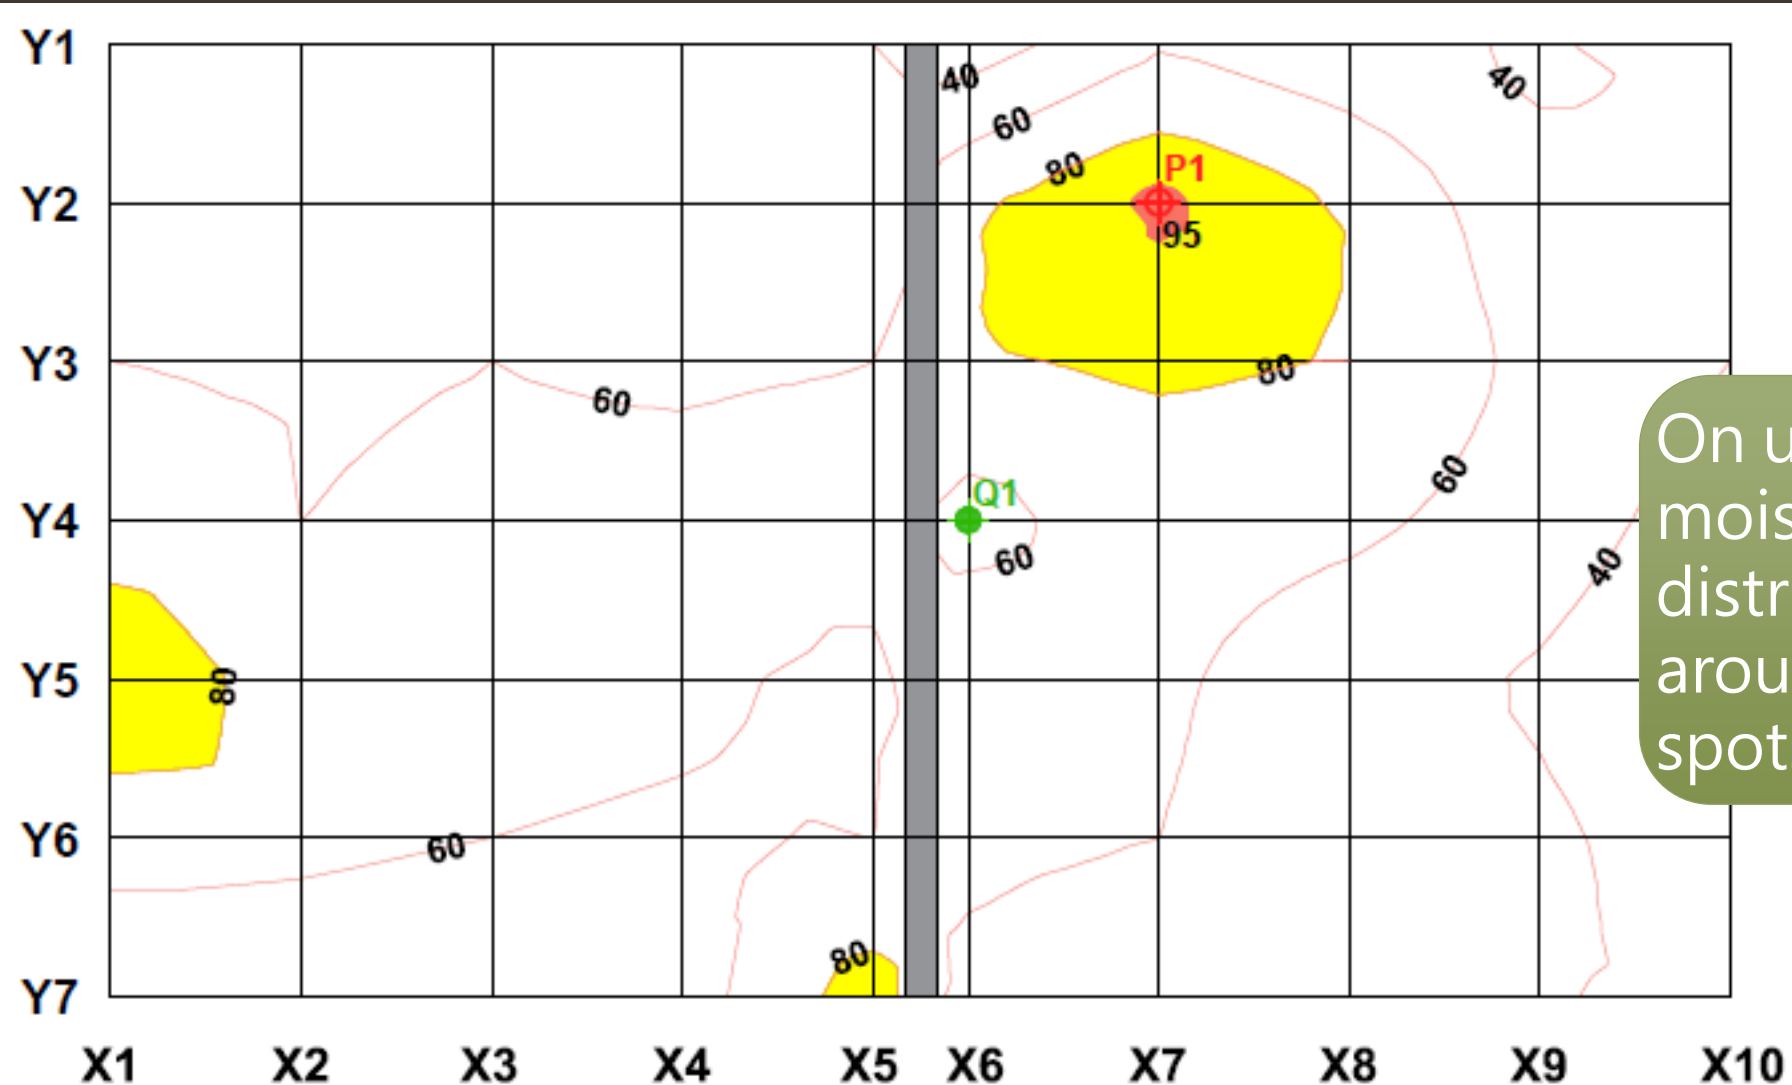
Moisture Contours Map for **DR1 & DR2** on 17/3/2015

On upper side, moisture is distributed around 3 different spots.

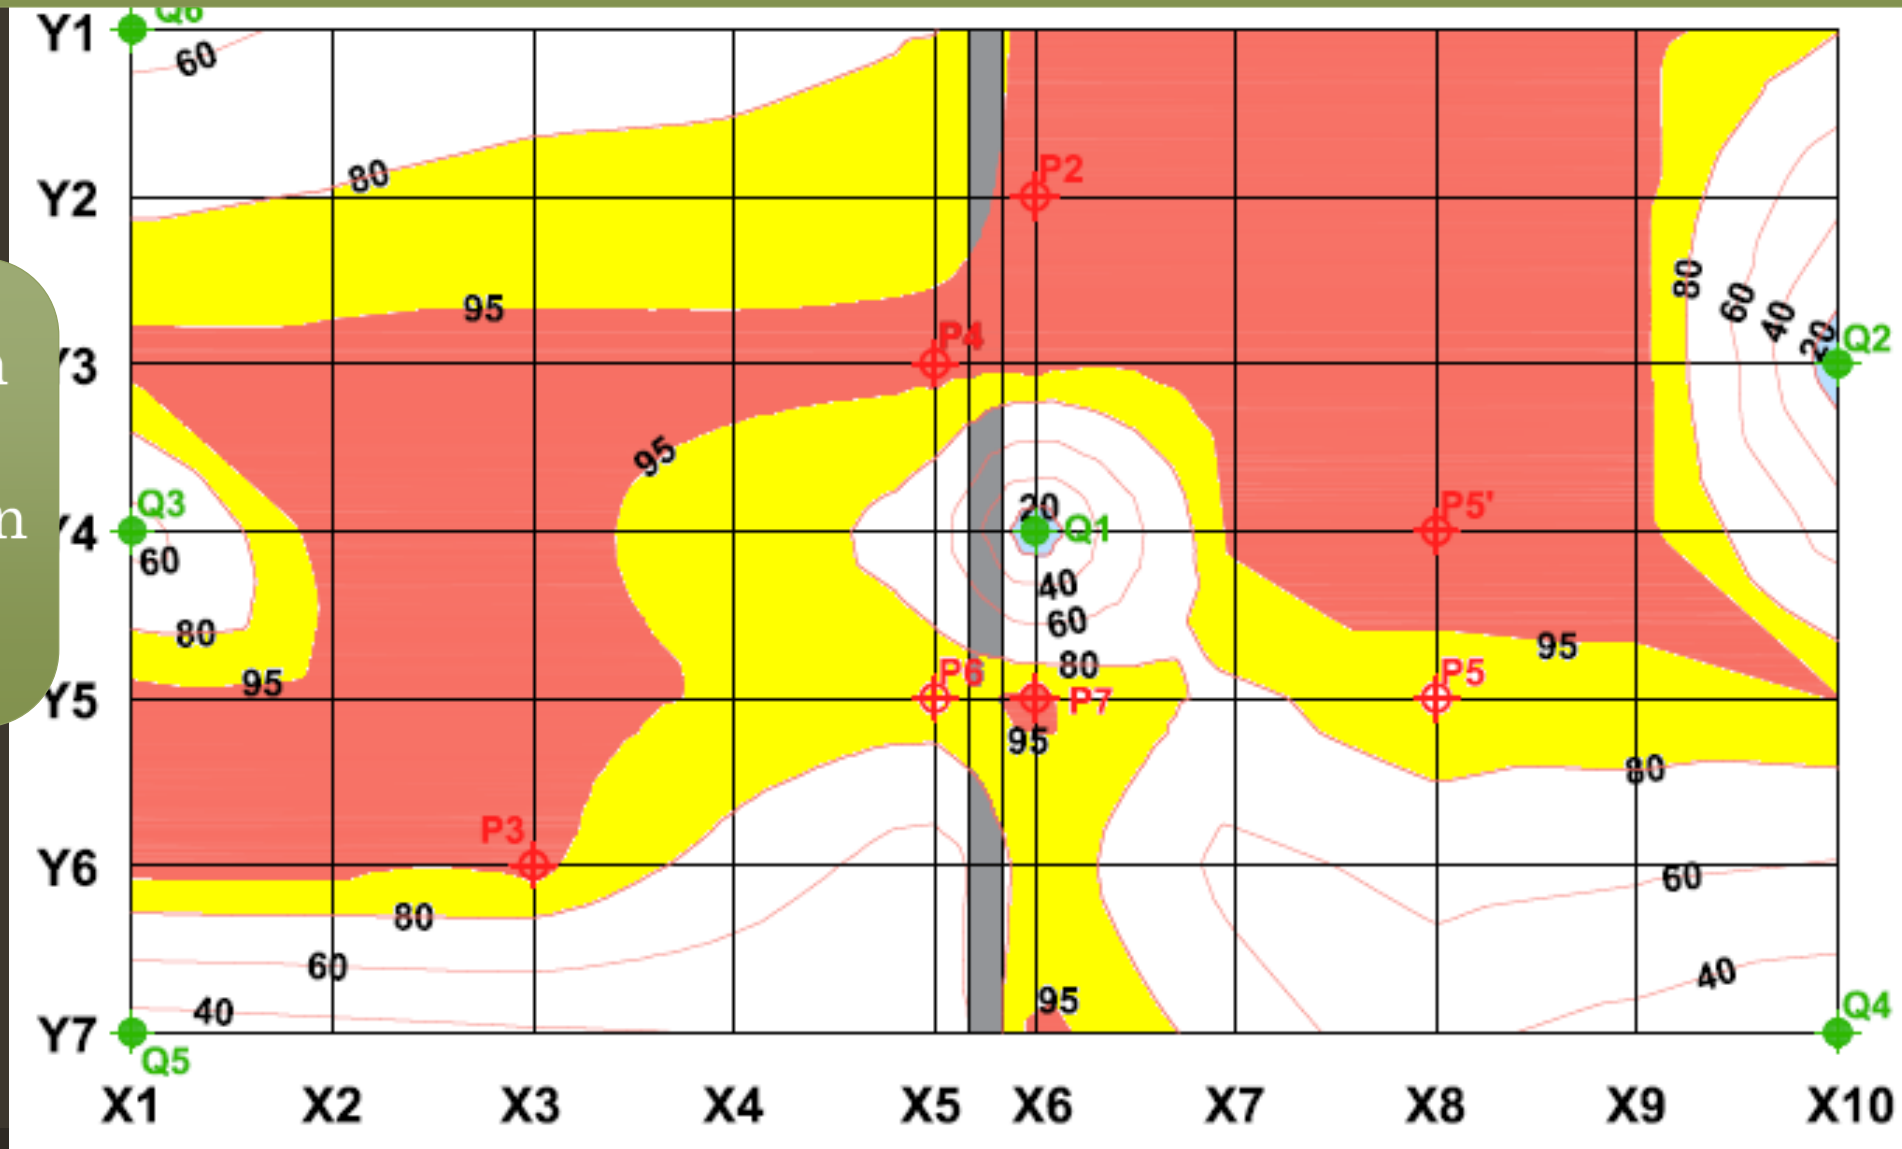
Moisture Contours Map for $T_3 = 9:30\text{pm}$, DR1 & DR2, 11/6/2015

Moisture in DR2 stabilized in $1\frac{1}{2}$ hr
