Building Surveyors Conference 2016:
Innovative Technologies in Building Surveying
Hong Kong Institute of Surveyors, 15 October 2016

Latest Research and Studies for Water Leakage Detection

Dr. Yu-Leuk CHOI

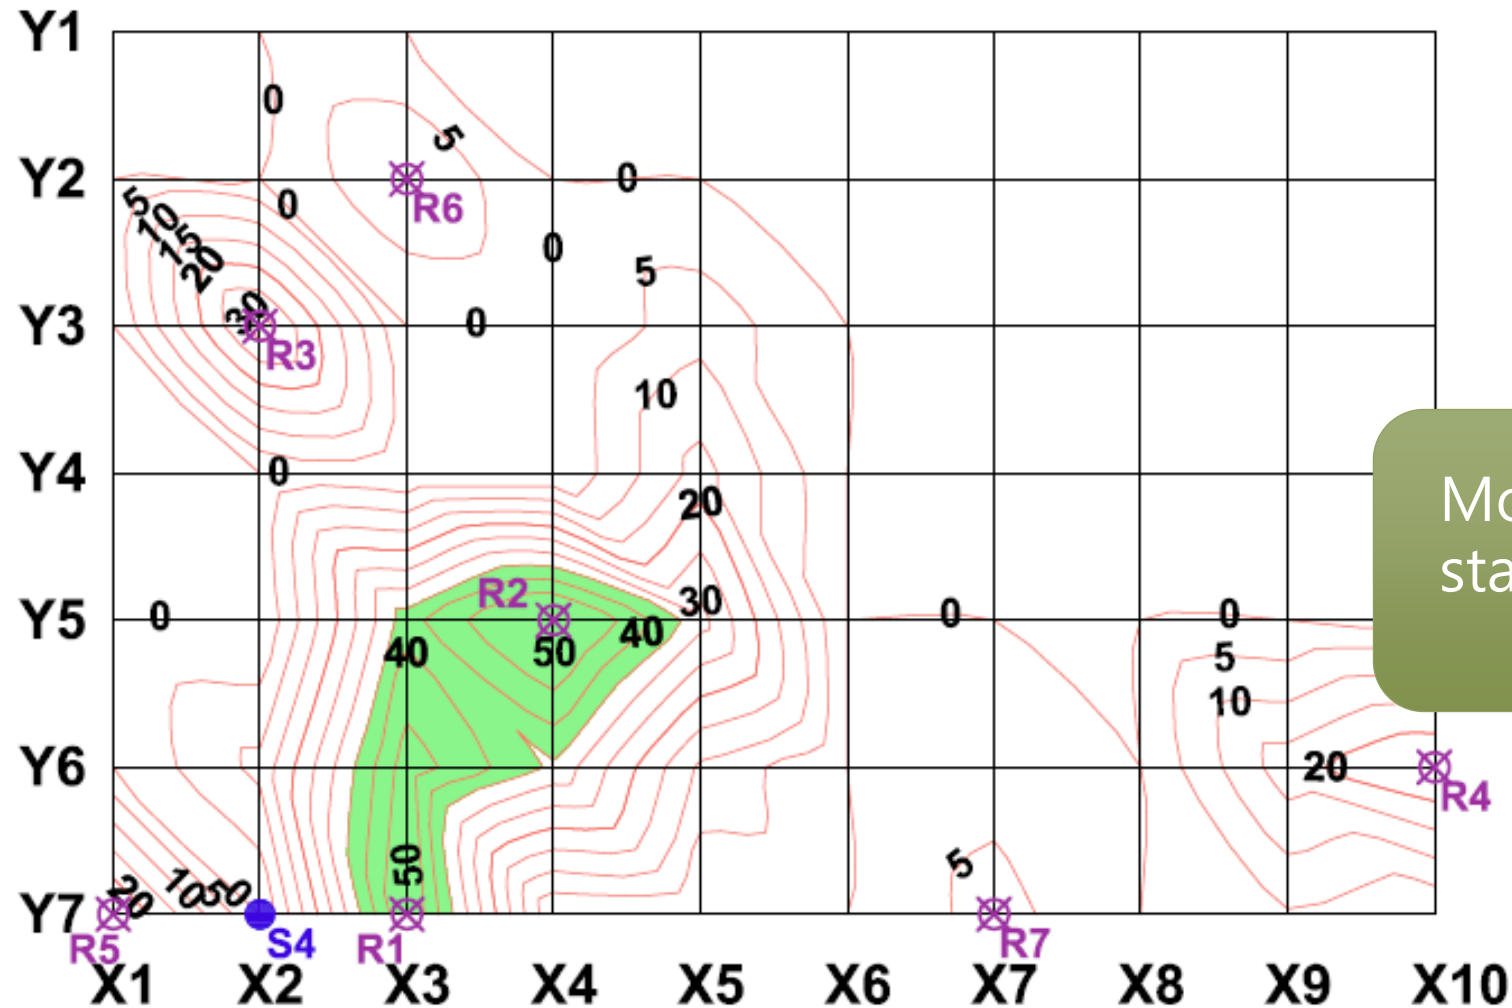
Moisture Contours Map for $T_2 = 9:00\text{pm}$, PT Room, 11/6/2015

Moisture pattern stabilized in 1hr.

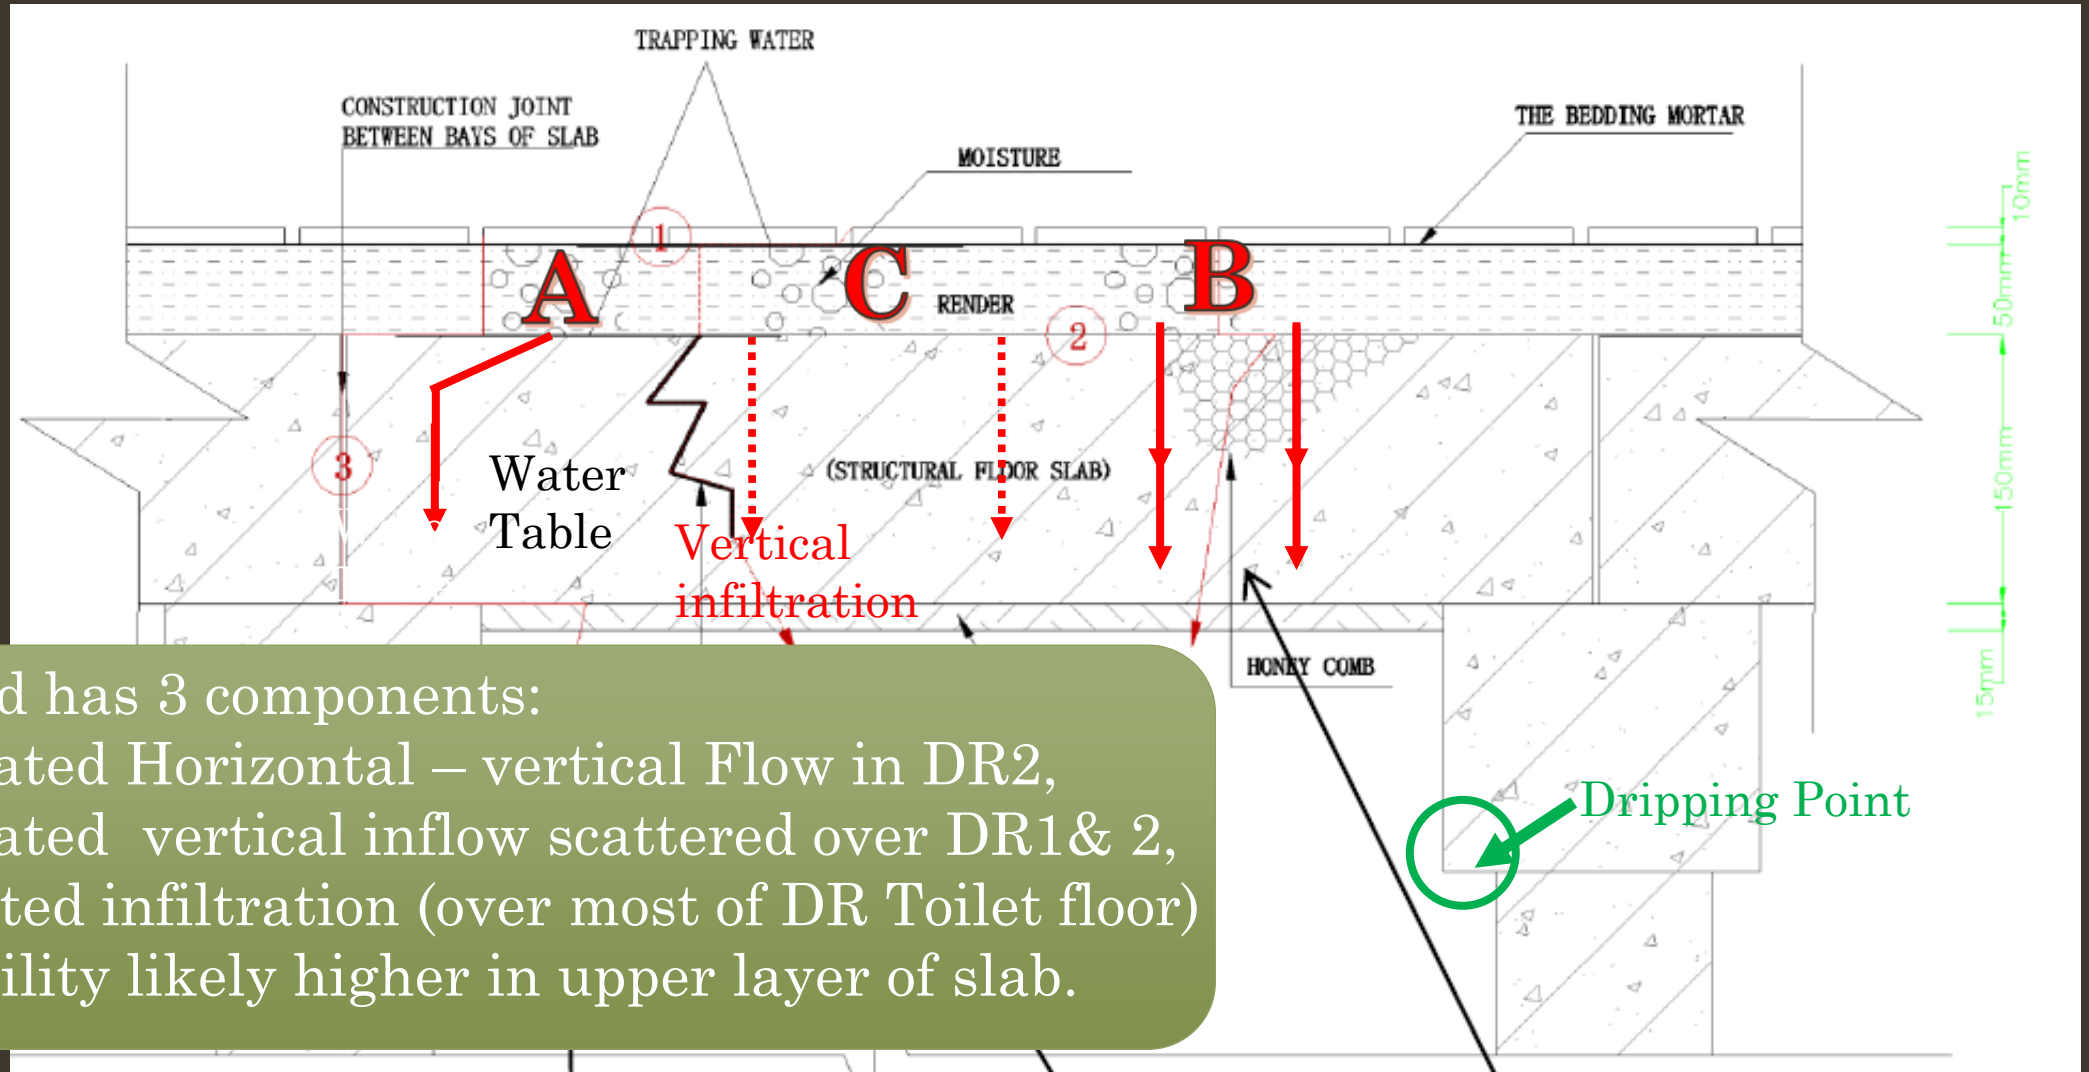
Conclusion from Ponding-Scanning Study

- Flow field has 3 components:
 - A:** Accentuated Horizontal – vertical Flow in DR2,
 - B:** Accentuated vertical inflow scattered over DR1 & 2,
 - C:** Distributed infiltration (over most of DR Toilet floor)
- Permeability likely higher in upper layer of slab.

- Impermeability of surface layer of slab may have been impaired during alteration works for change of use of premises.
- Improving water tightness of tile binding layer may be more economical remedy to a mildly leaky floor slab.

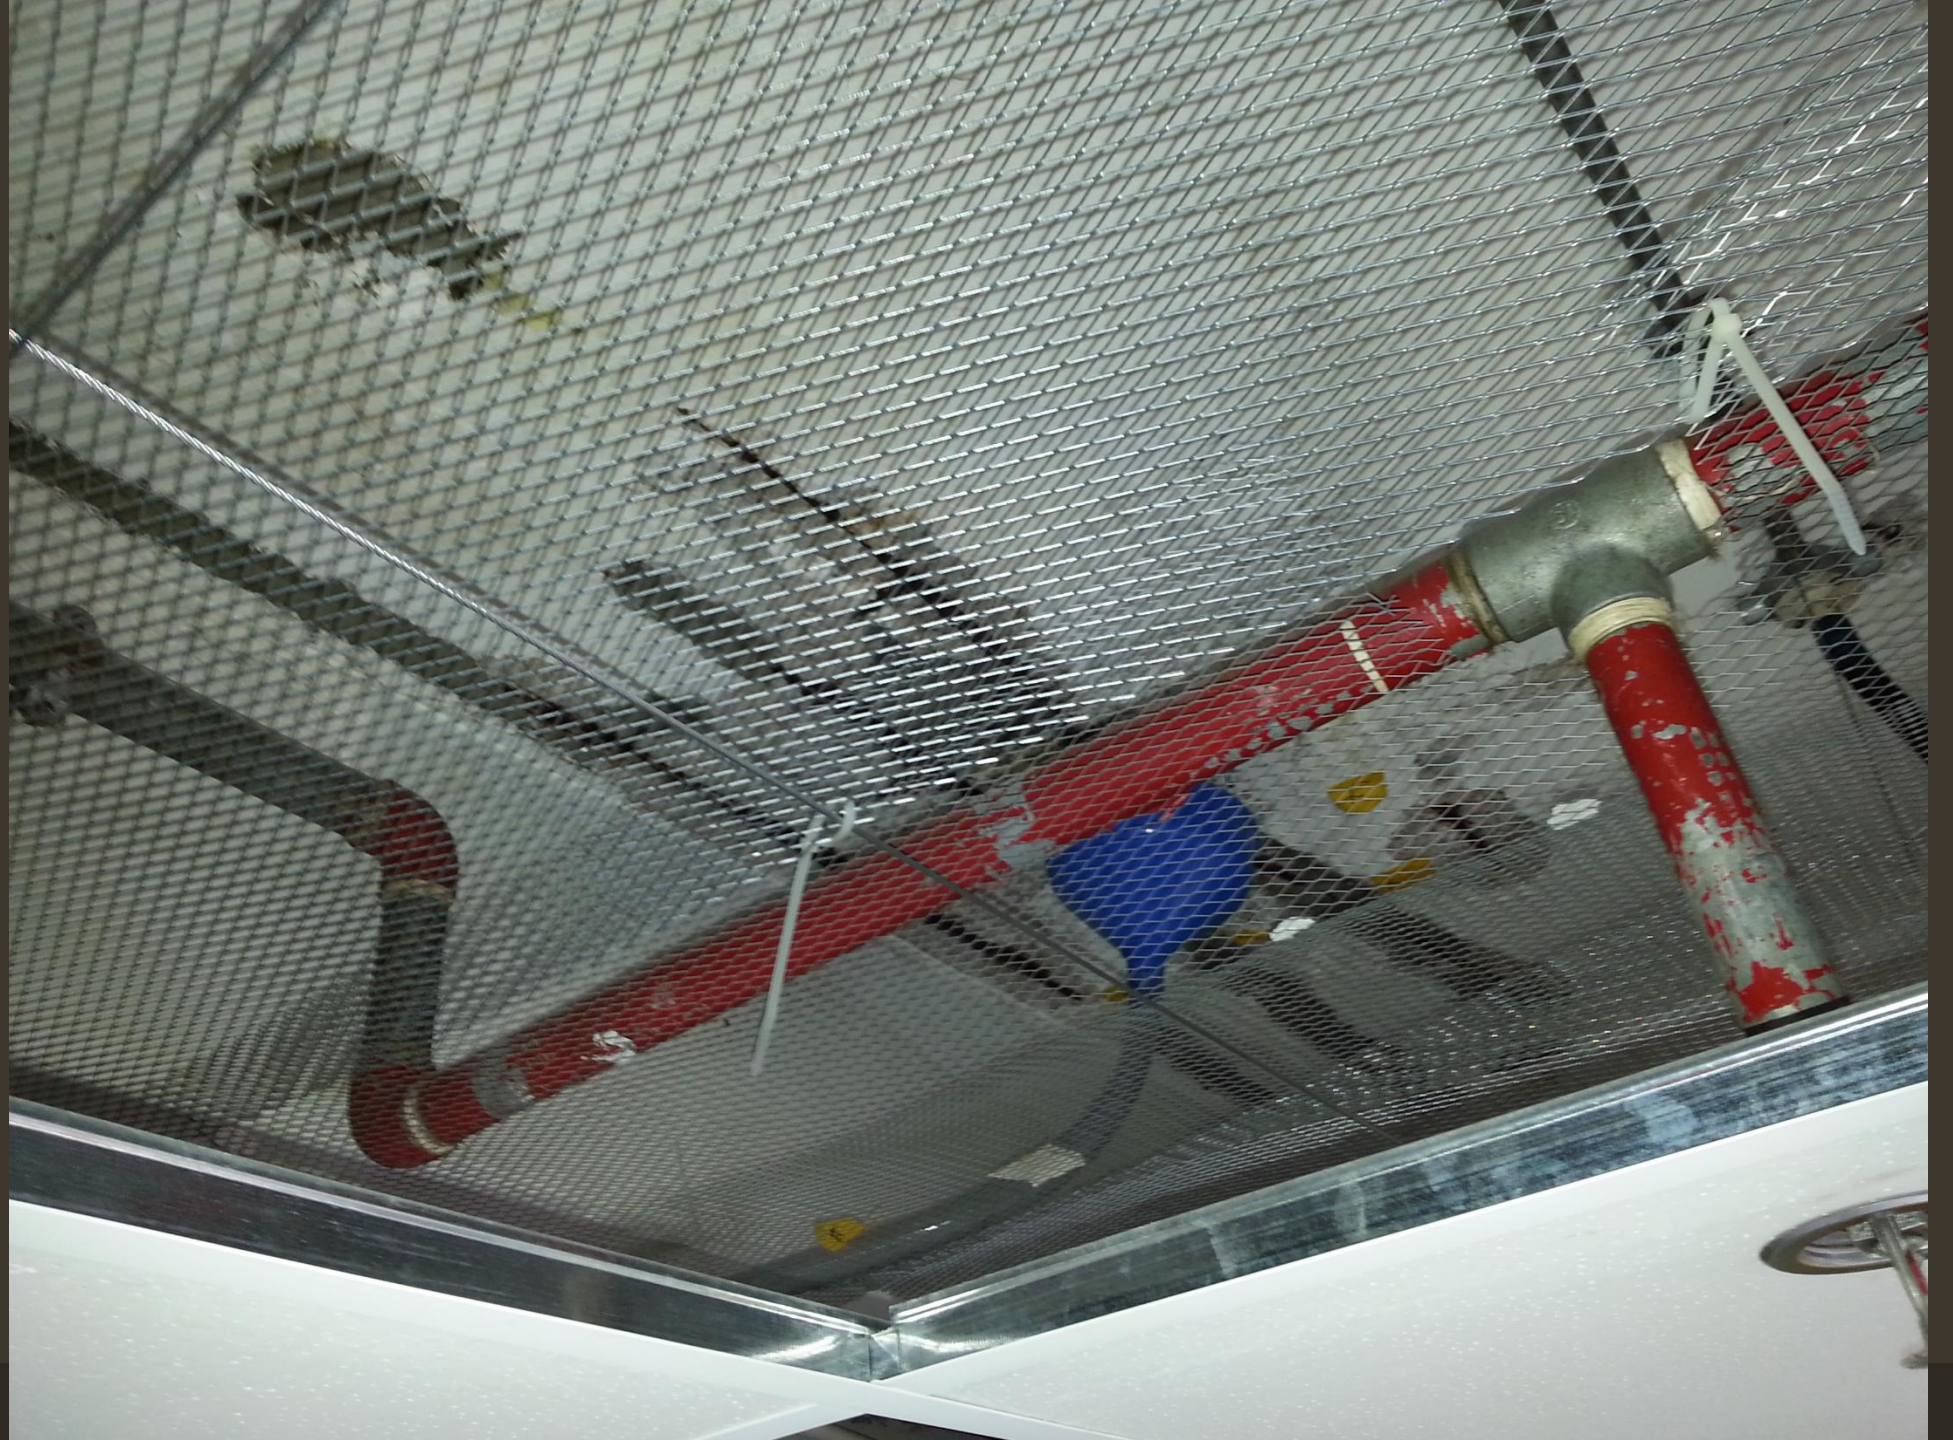
Application to
investigating
building
seepage case
in
Shan Shui Po

1. Seepage inflow from upstairs toilet floor and from UBW on flat roof.
2. Appropriate follow up action:-
 - Repair by concerned owners, or
 - Report to BD/FEHD for enforcement action.
