Building Surveyors Conference 2016:
Innovative Technologies in Building Surveying
Hong Kong Institute of Surveyors, 15 October 2016

Latest Research and Studies for Water Leakage Detection

Dr. Yu-Leuk CHOI

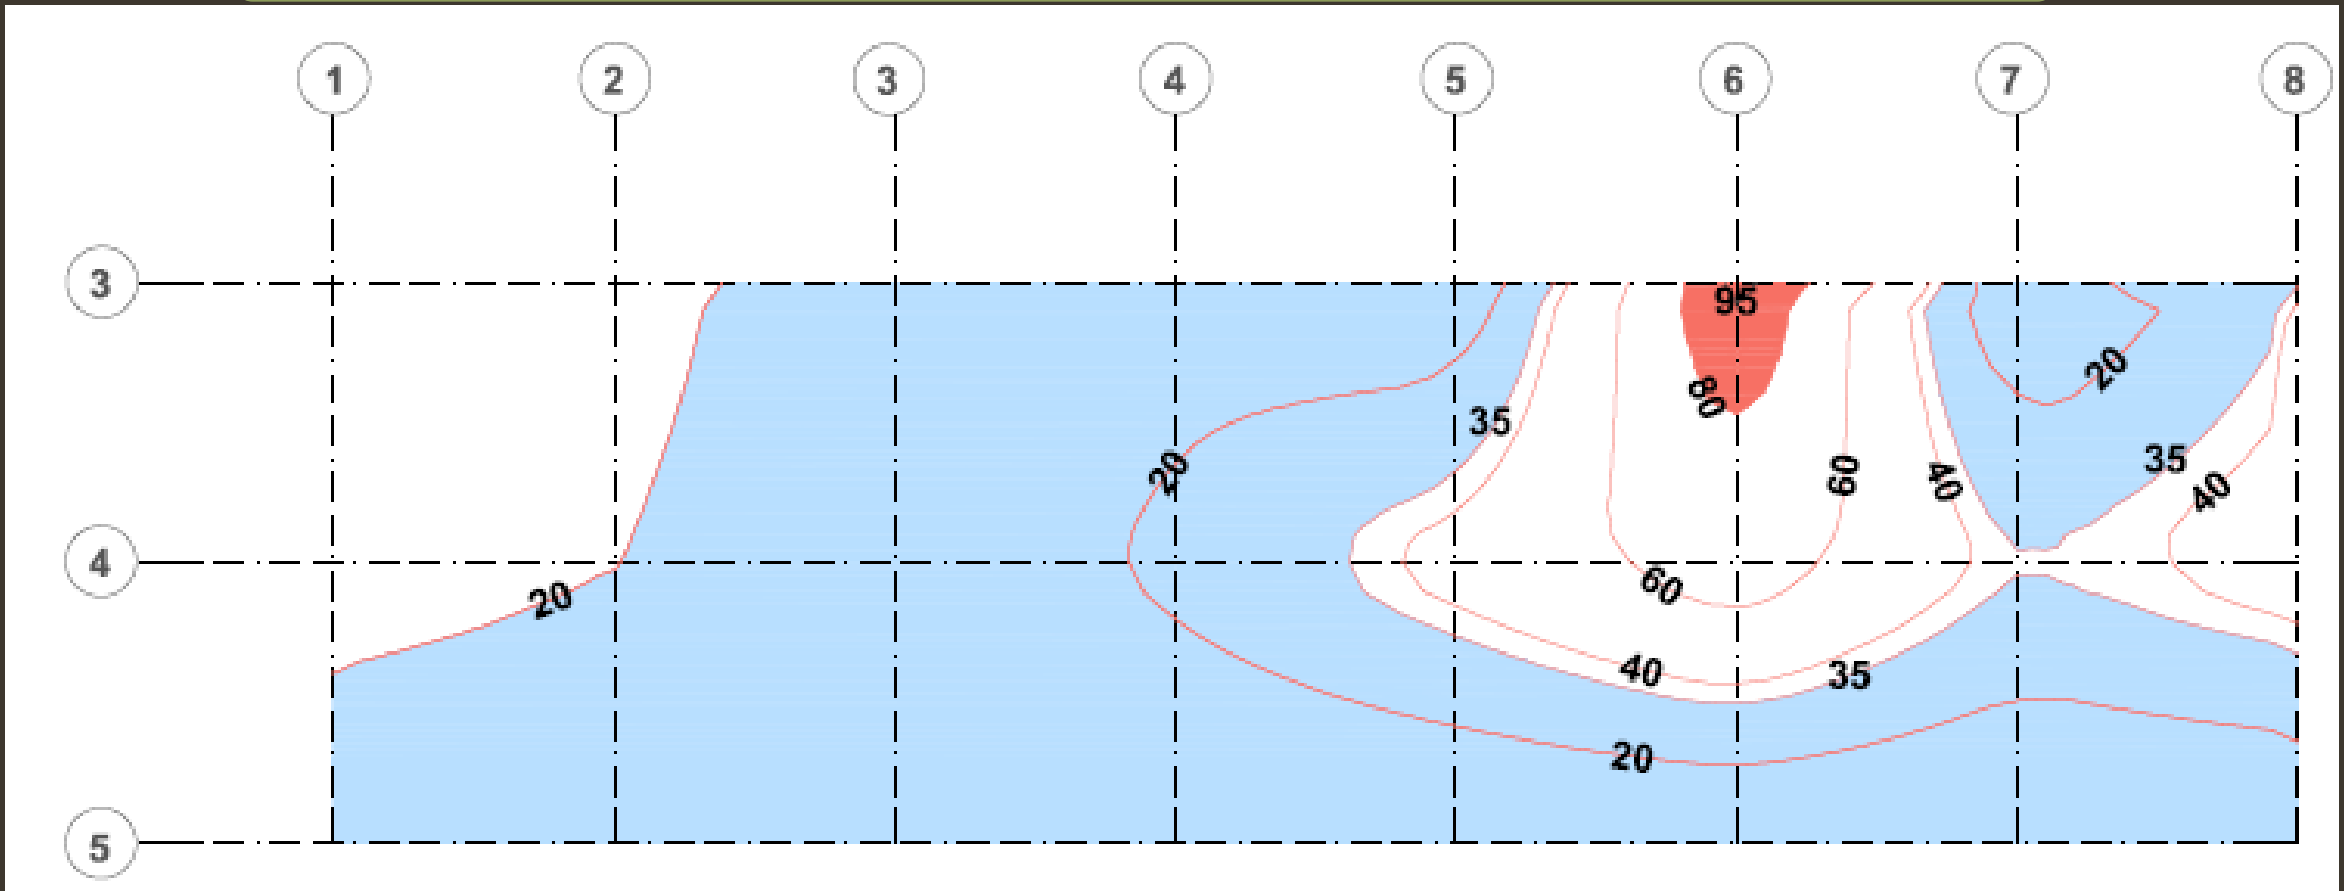
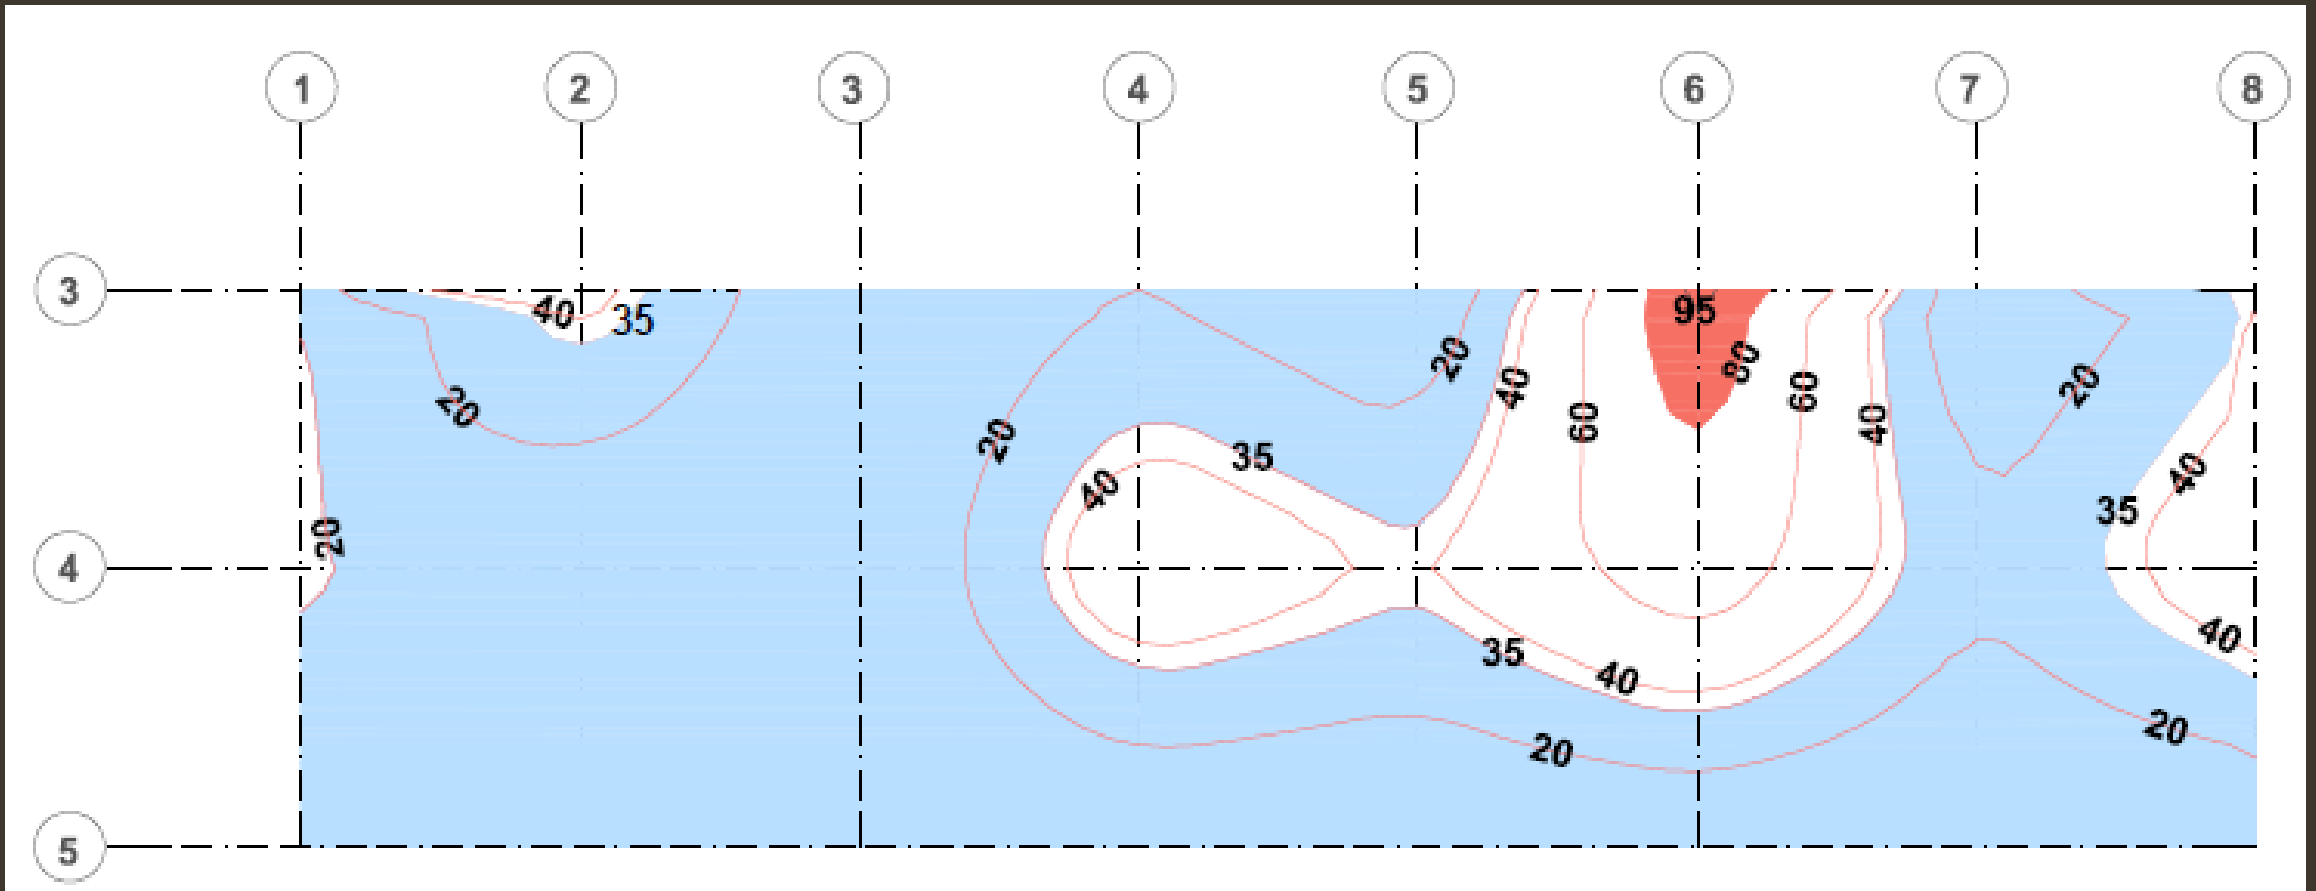
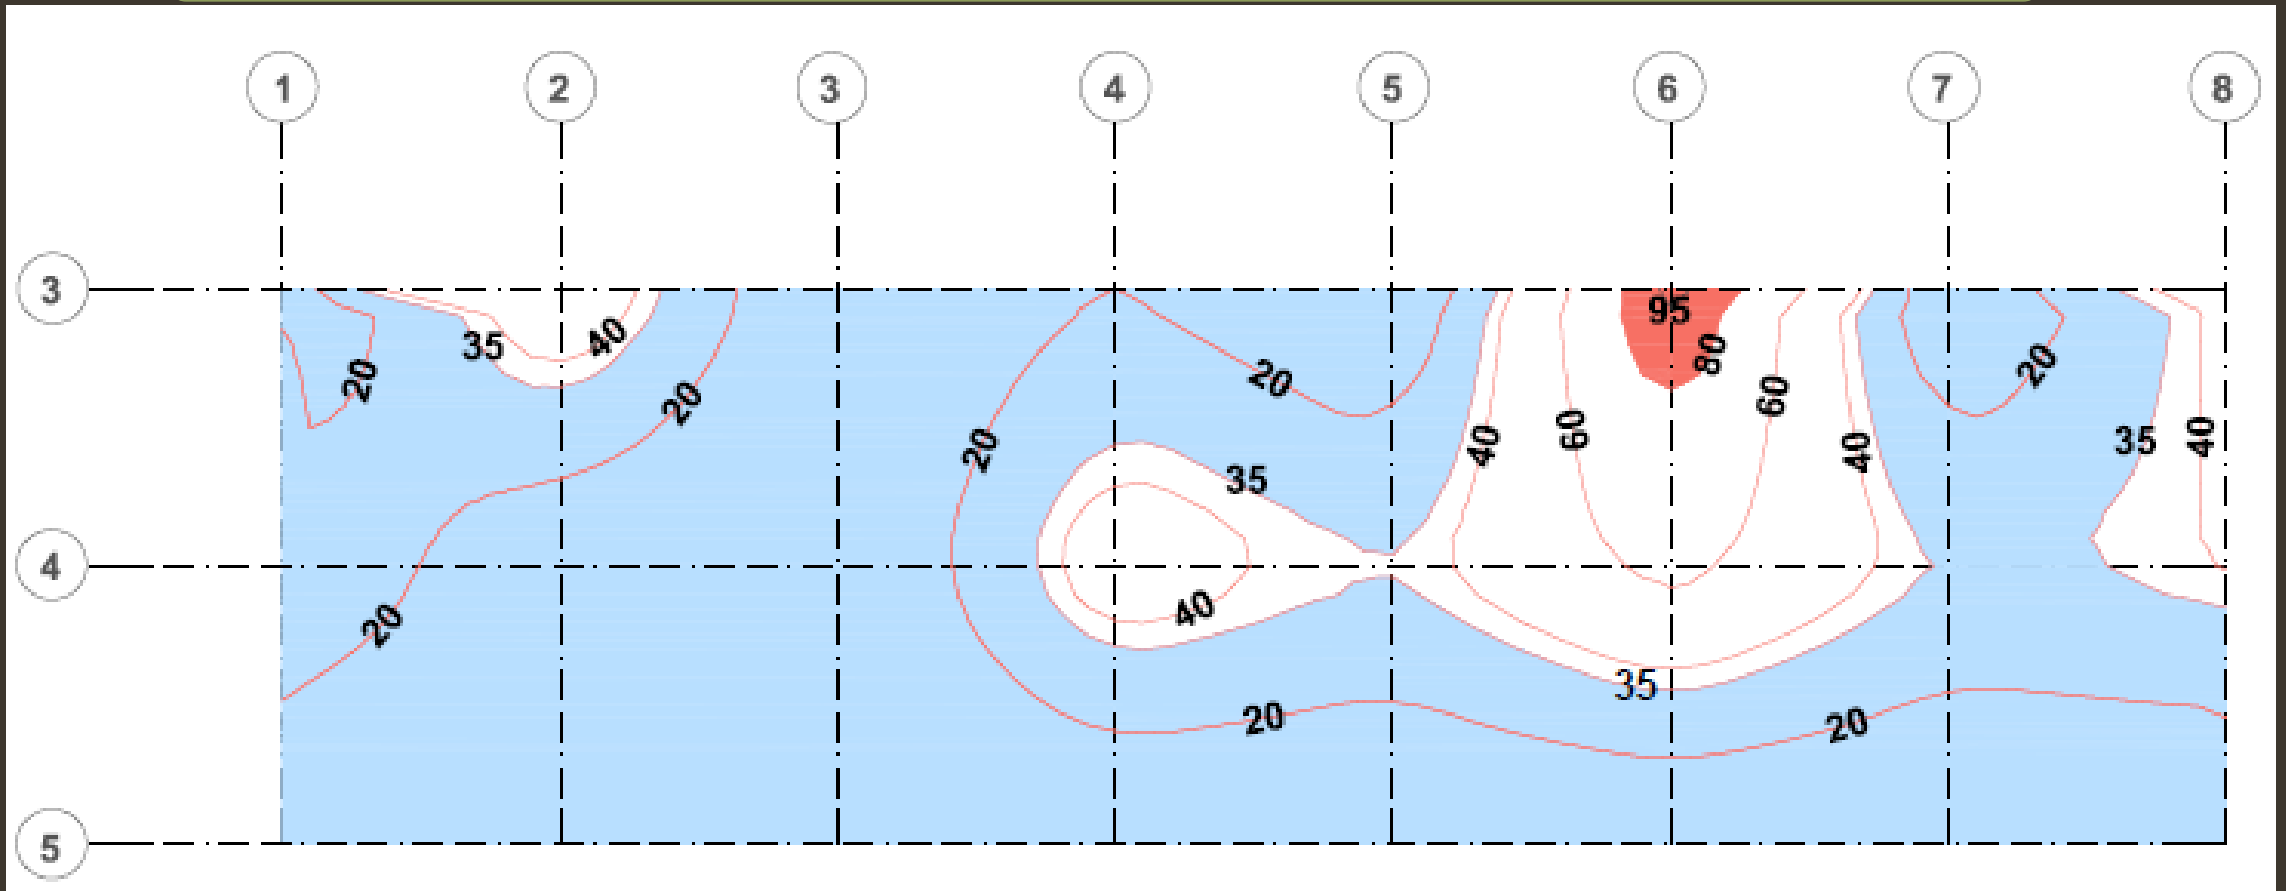
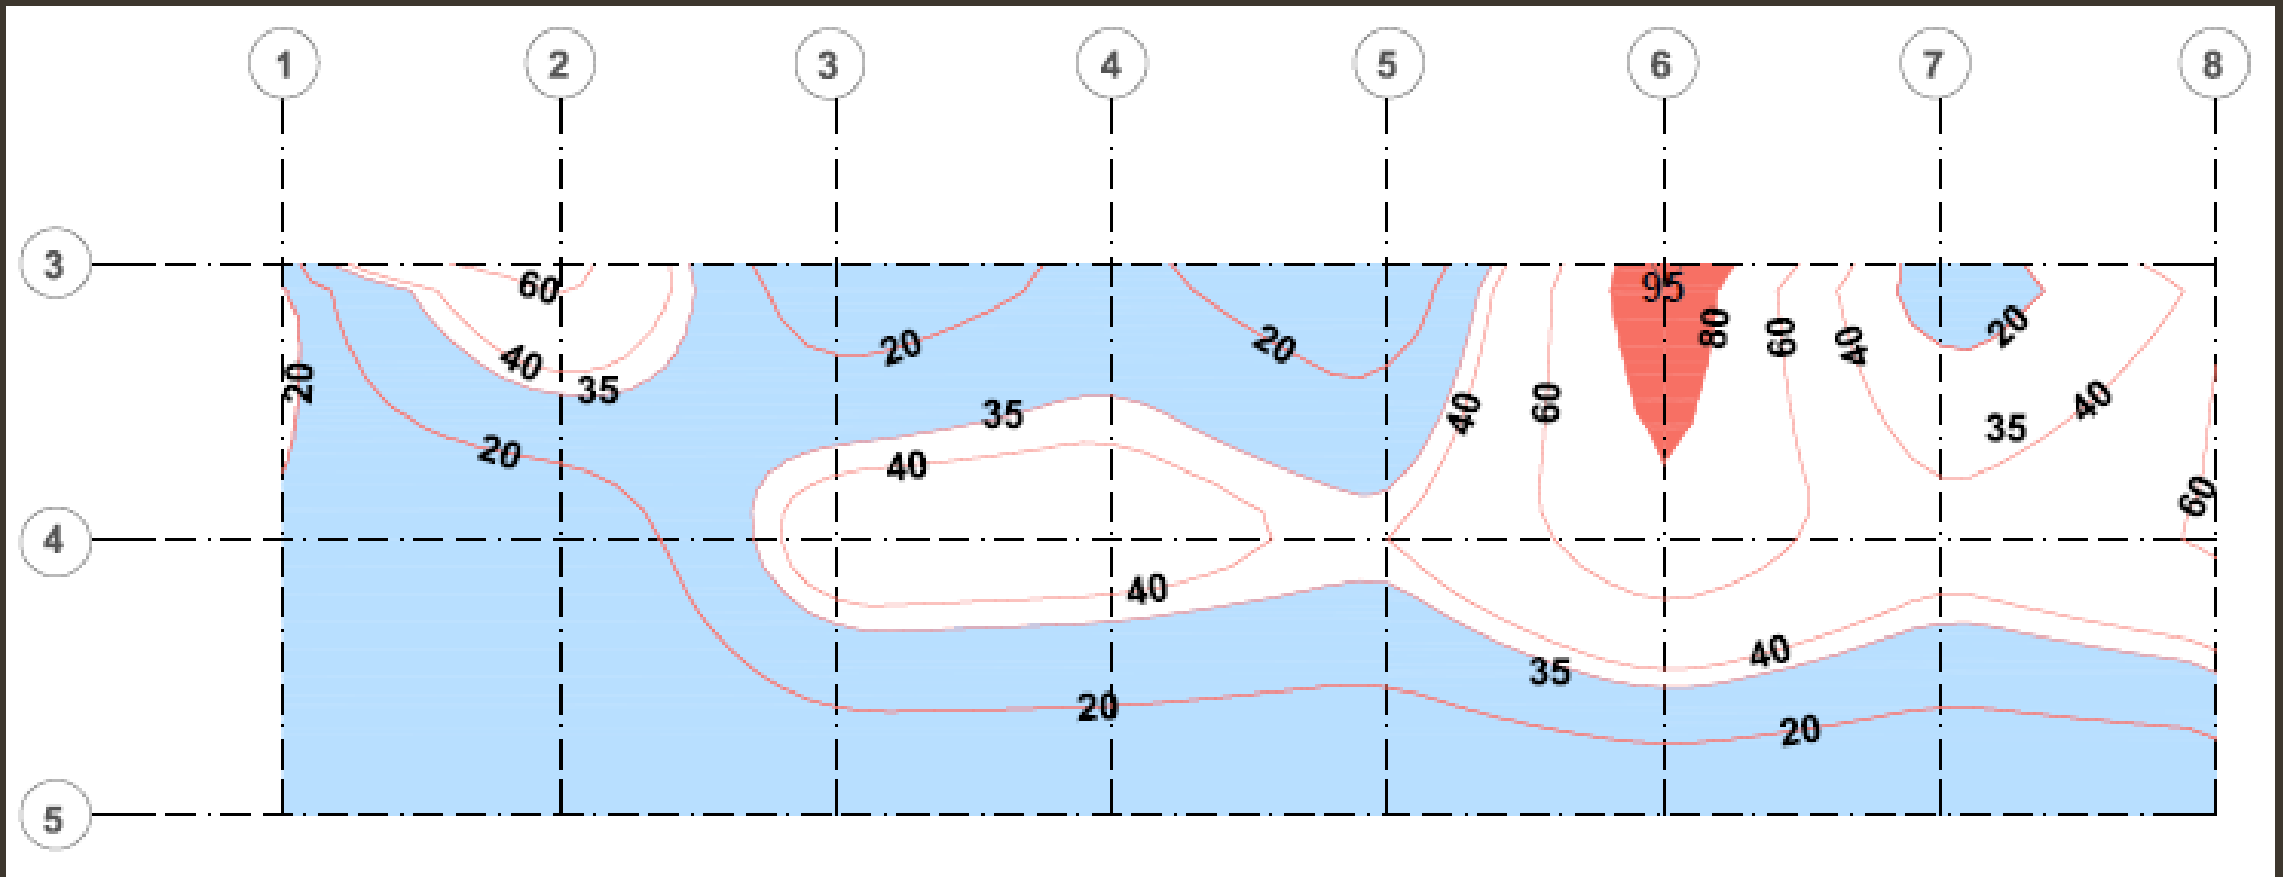
Moisture Contours Map at $T_2 = 11:41$ on 17/4/2015

Moisture Contours Map at $T_5 = 12:26$ on 17/4/2015

Moisture Contours Map at $T_7 = 12:56$ on 17/4/2015

Moisture Contours Map at $T_9 = 13:26$ on 17/4/2015

- 3 separate streams
- Rate of descent of 80 contour $\sim 1 \text{ cm/h} \sim 2.8 \times 10^{-3} \text{ mm/s}$
- Compare with concrete permeability of 10^{-5} . Hence flow turns horizontal above RC beam.
- Time to descend from Y1 to Y3 $\sim 1 \text{ m} / (1\text{cm/h}) \sim 100 \text{ h} = 4.2 \text{ days}$. Hence flow below Y3 on 17/4/2015 is from wall infiltration only.
- Validated by subsequent **ponding-scanning test** on 16/6/2015

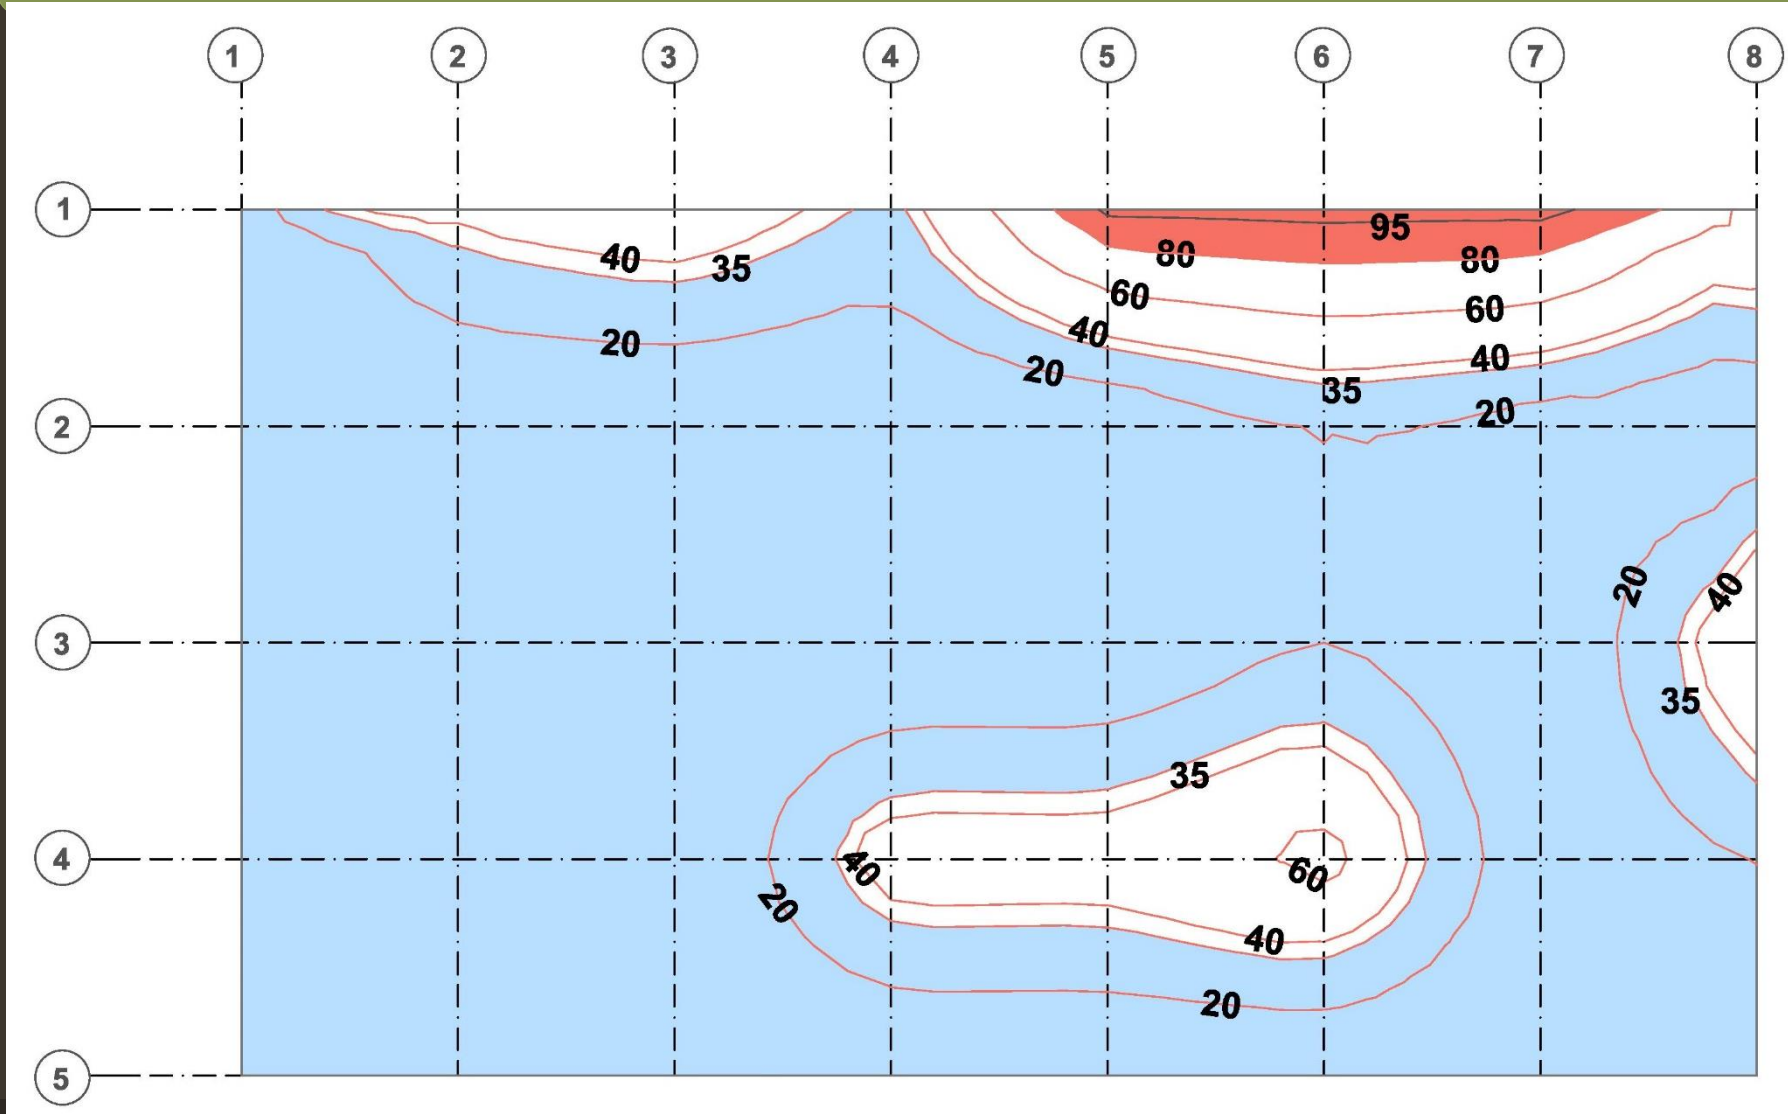
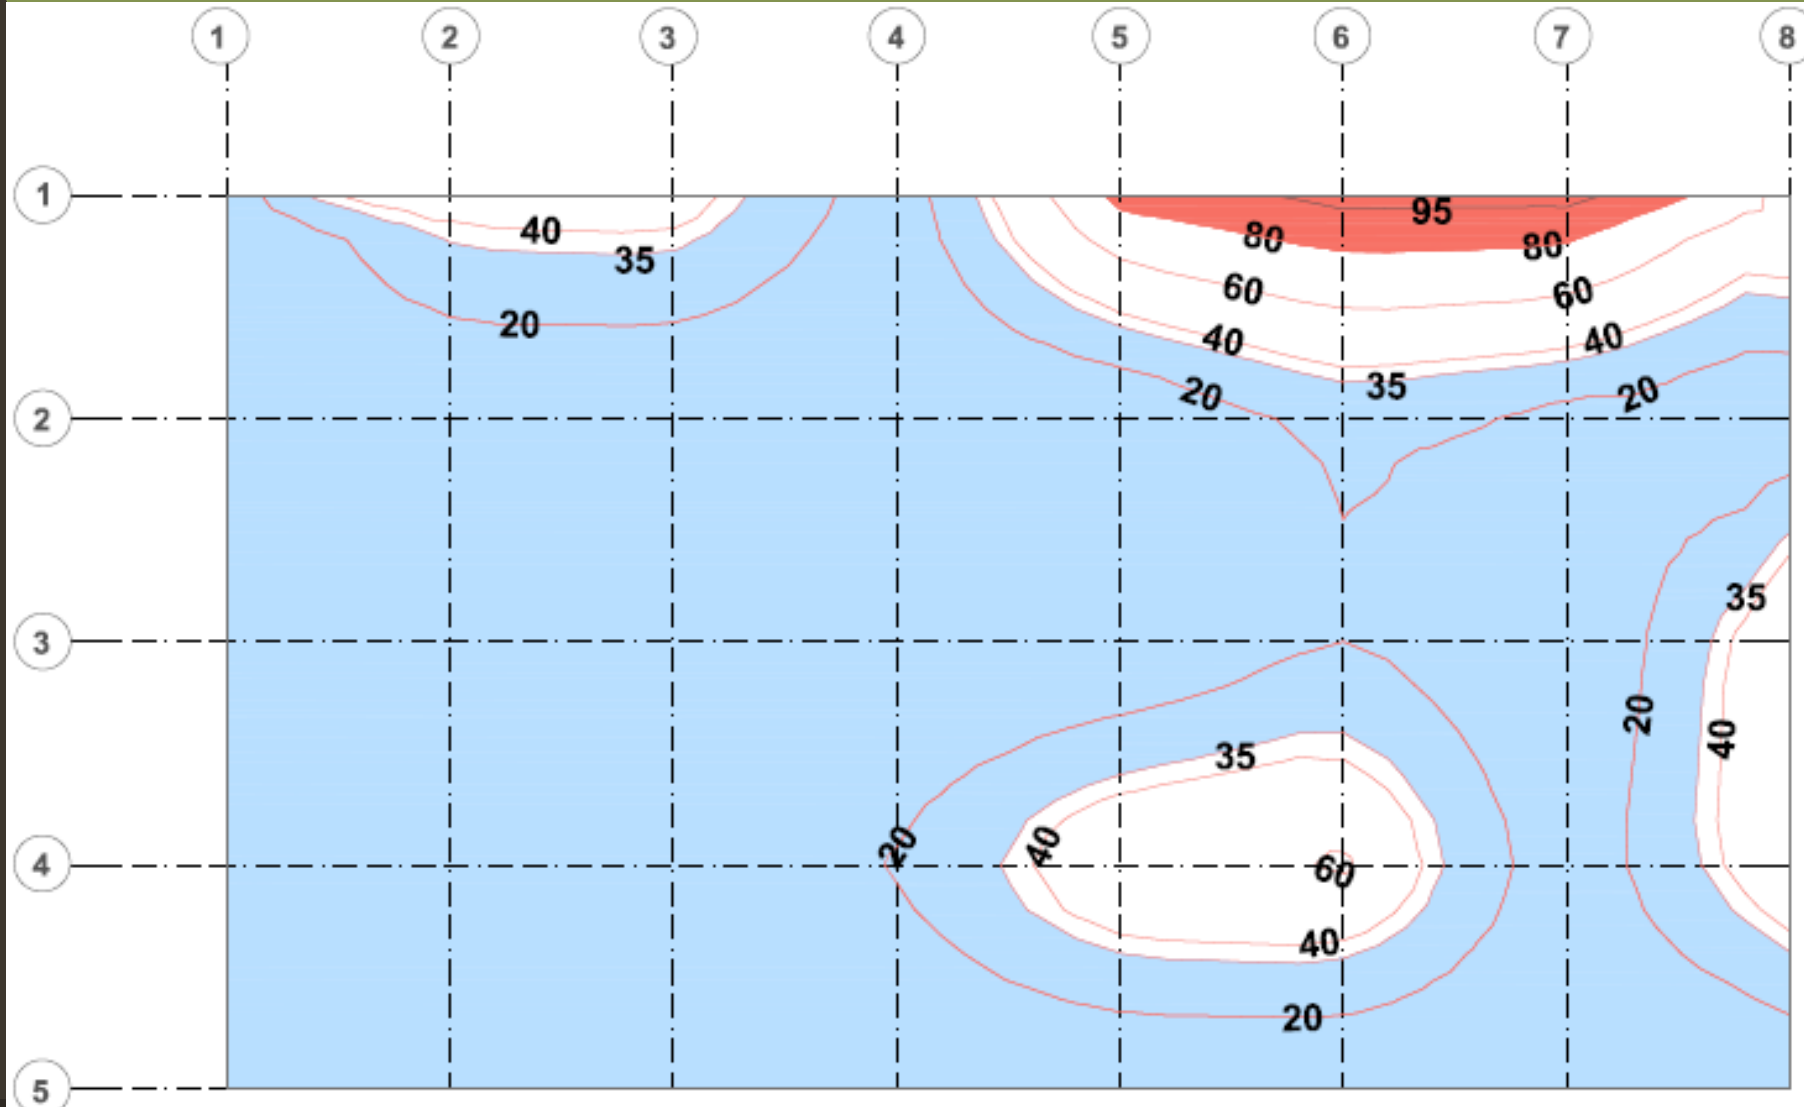
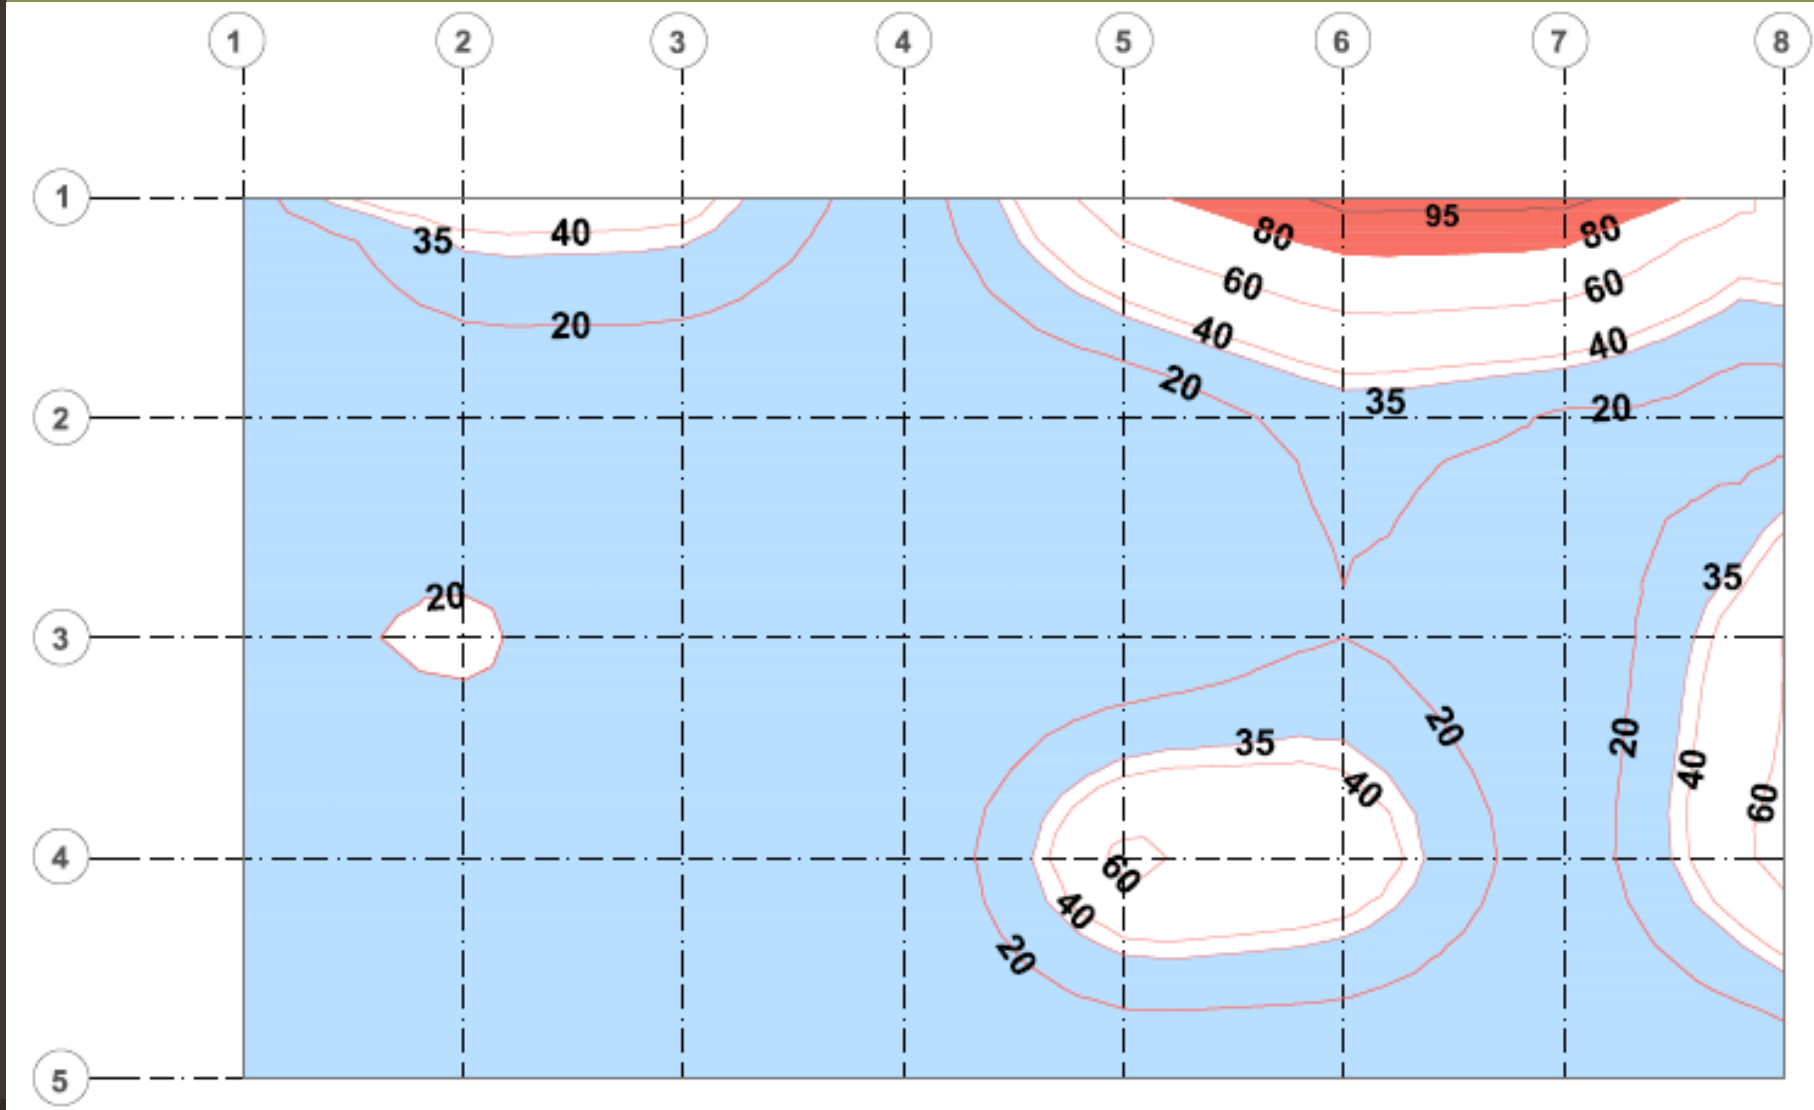
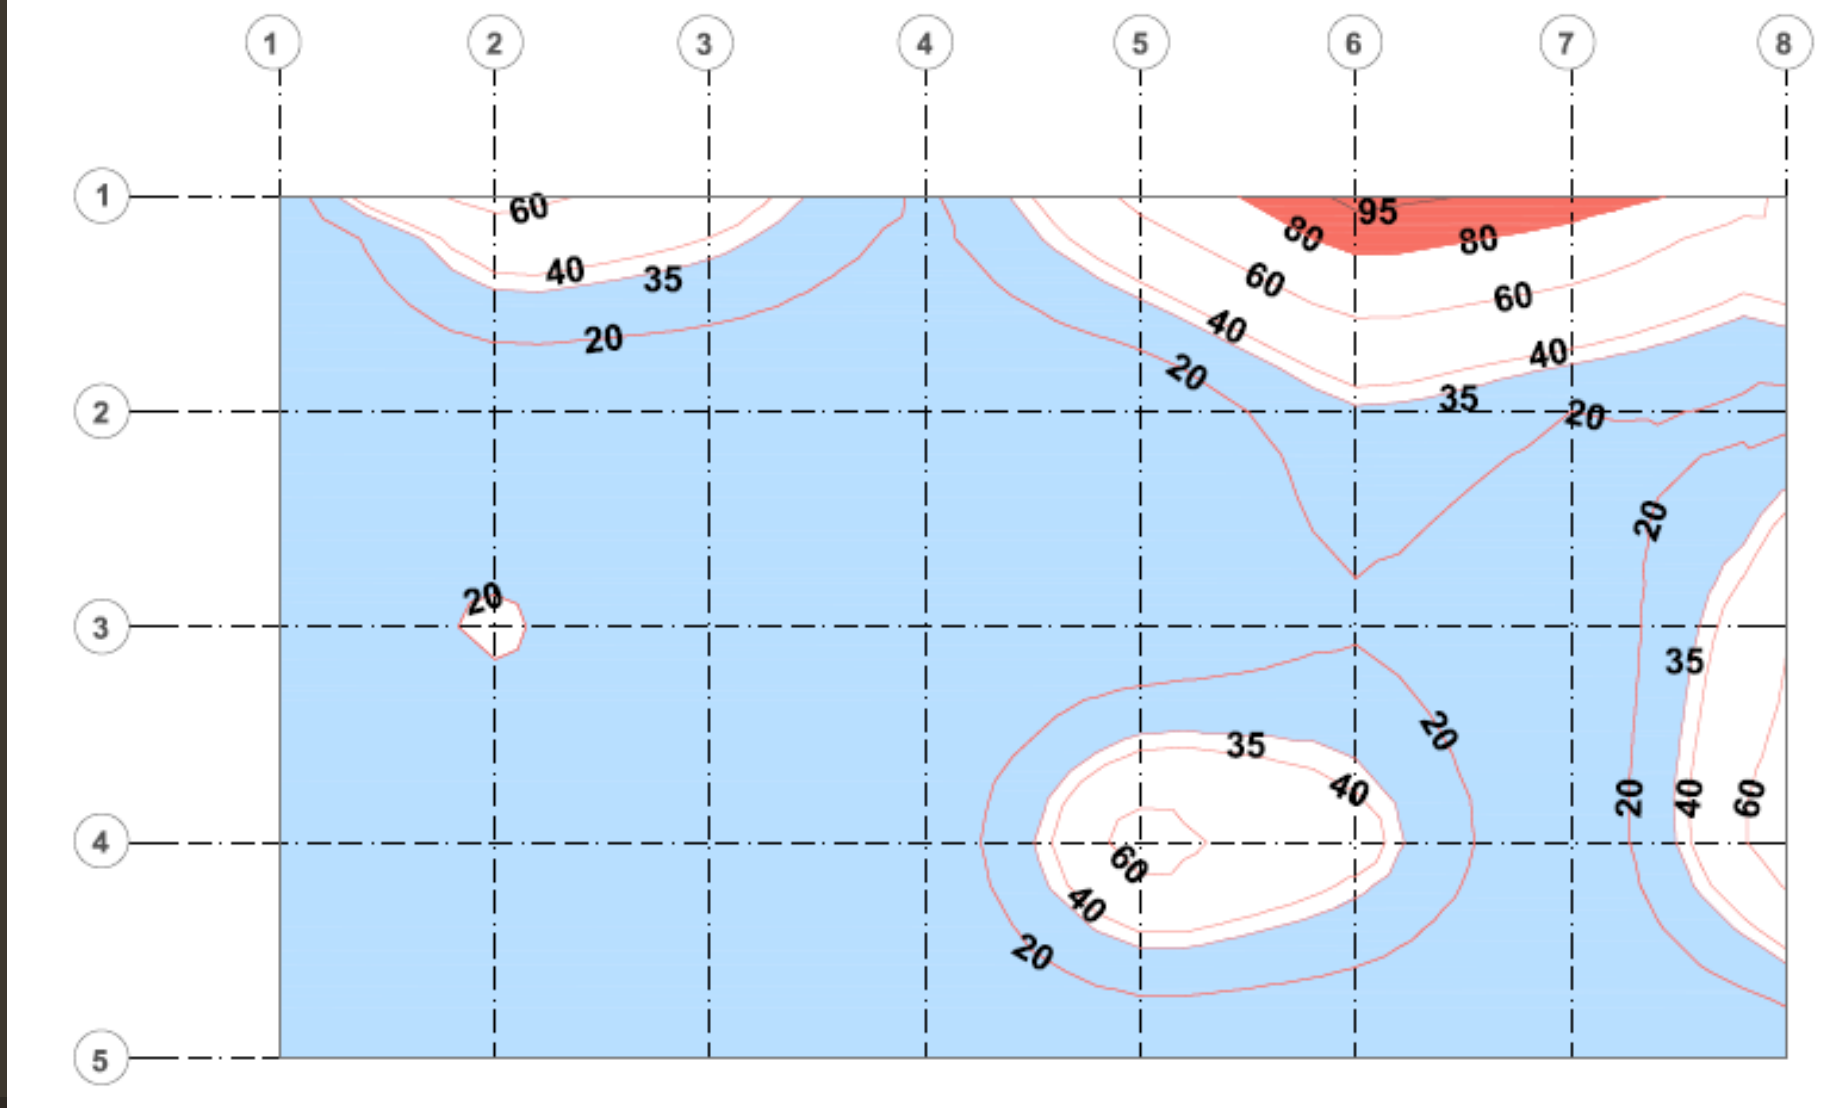
Moisture Contours Map at $T_3 = 13:04$ on 16/6/2015

Moisture Contours Map at $T_6 = 13:49$ on 16/6/2015

Moisture Contours Map at $T_8 = 14:19$ on 16/6/2015

Moisture Contours Map at $T_{10} = 14:49$ on 16/6/2015

Descending Flow
< 1 cm /hr,
both dates.
Hence, lower
moisture patch is
residual from
17/4/15

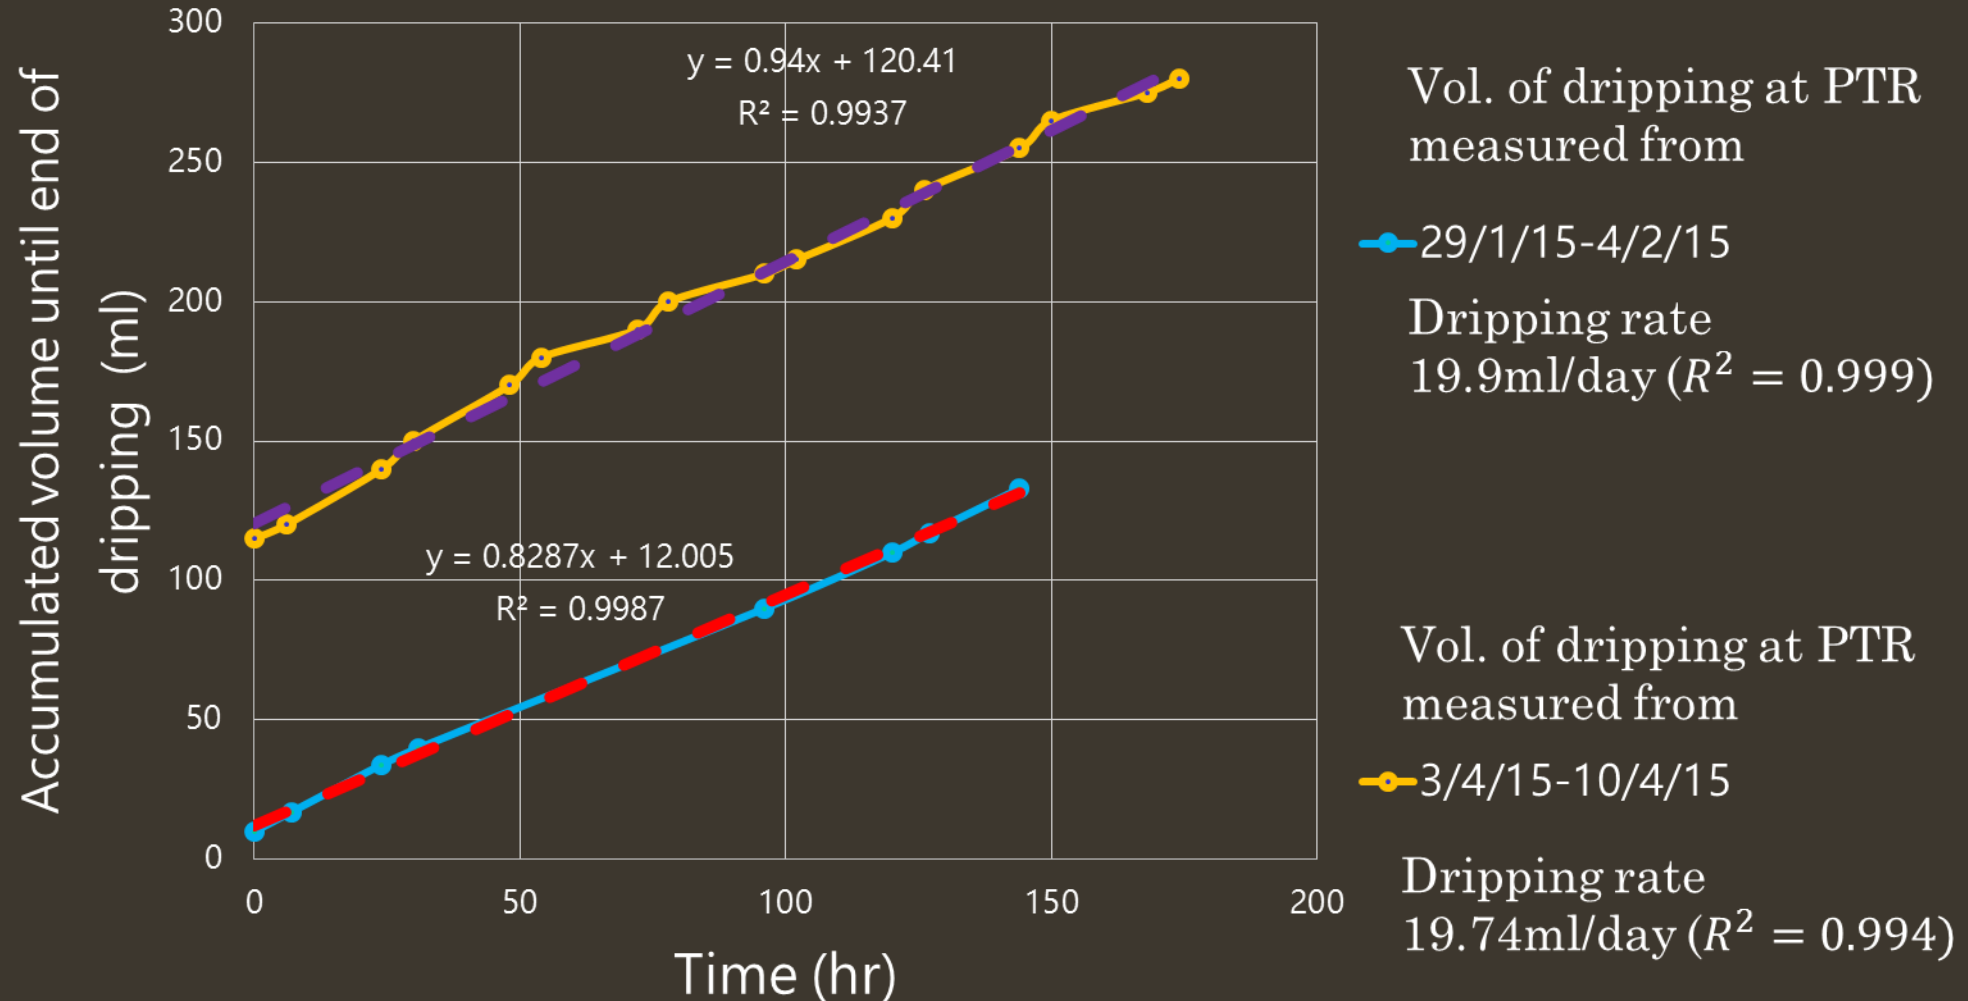
Constancy of Dripping Rate

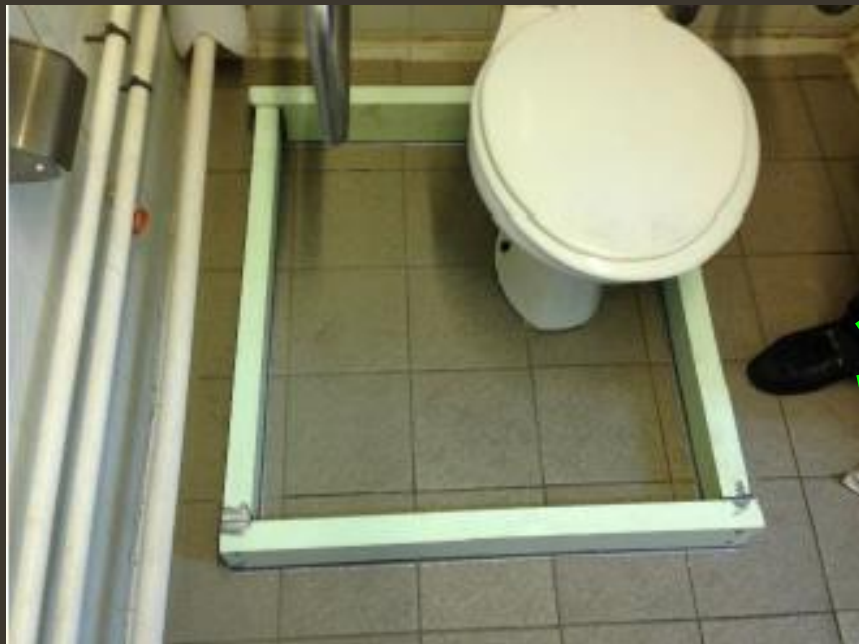
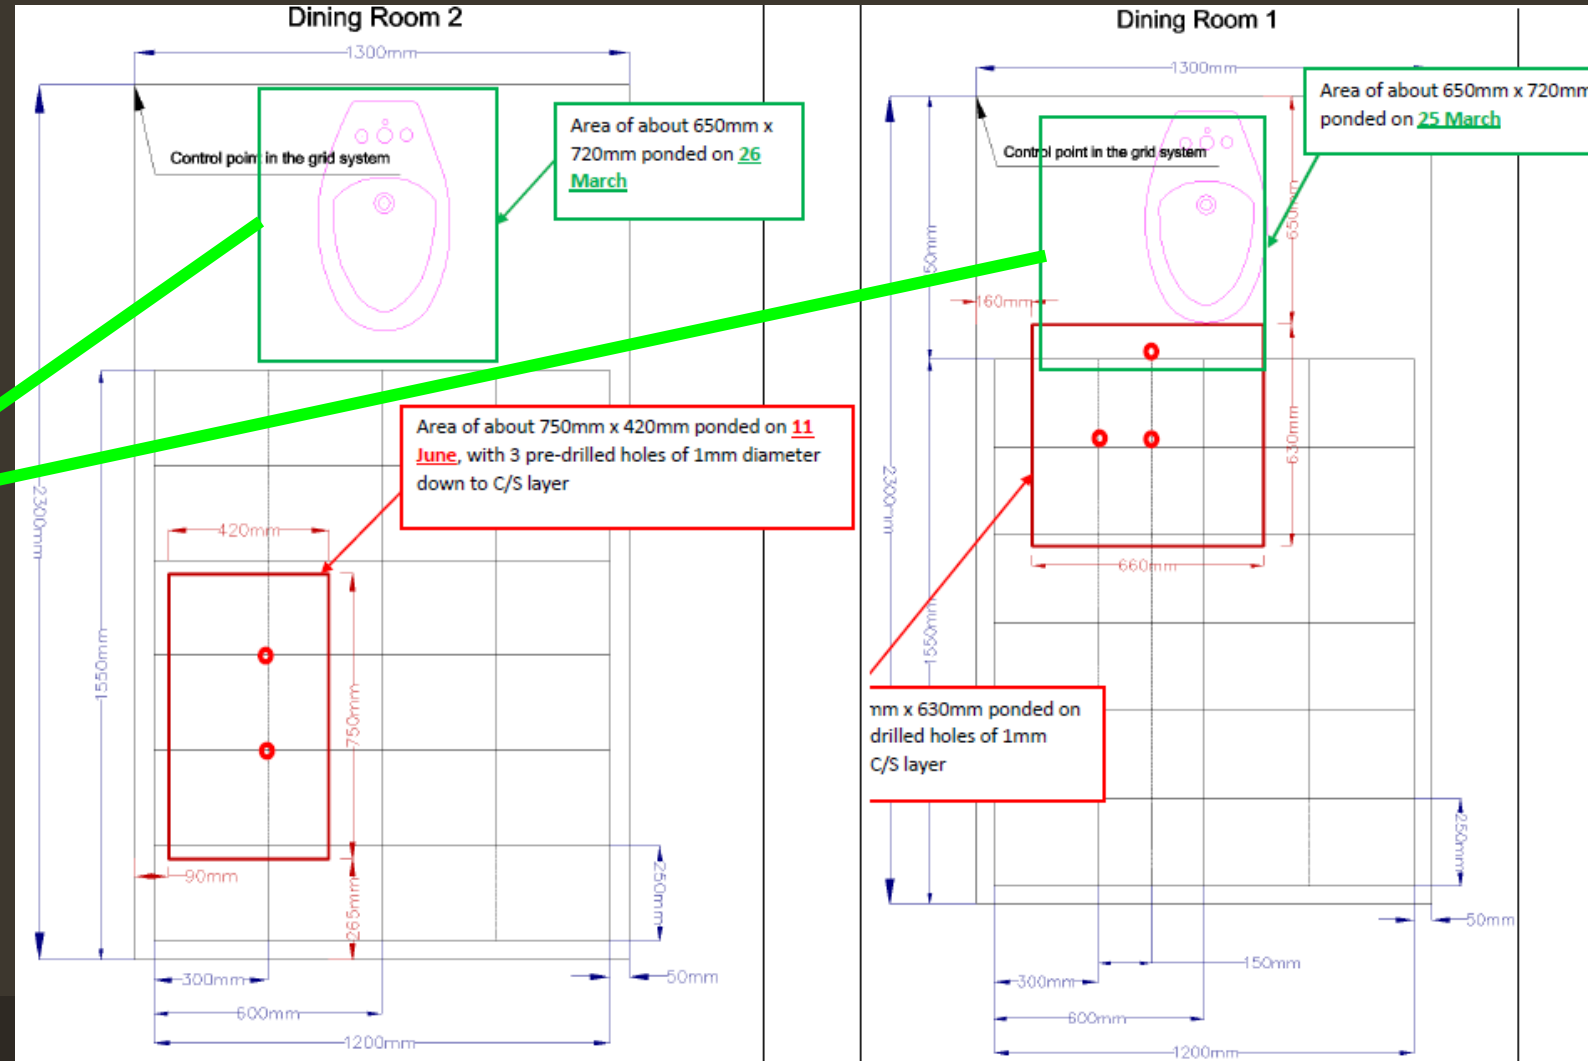
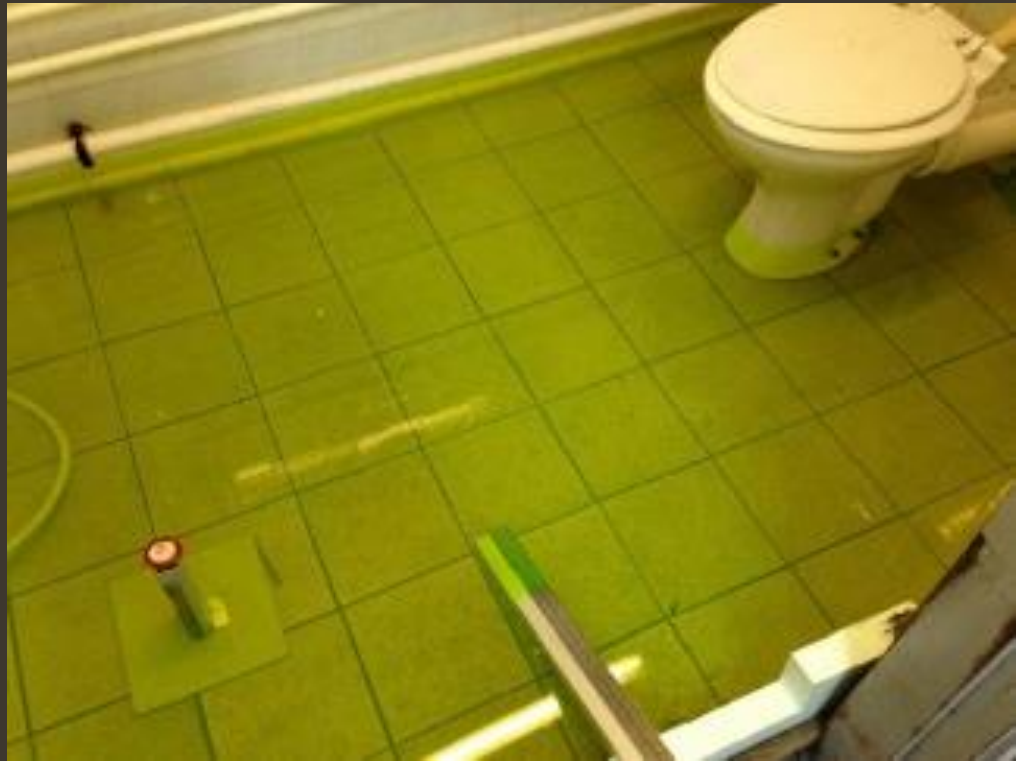
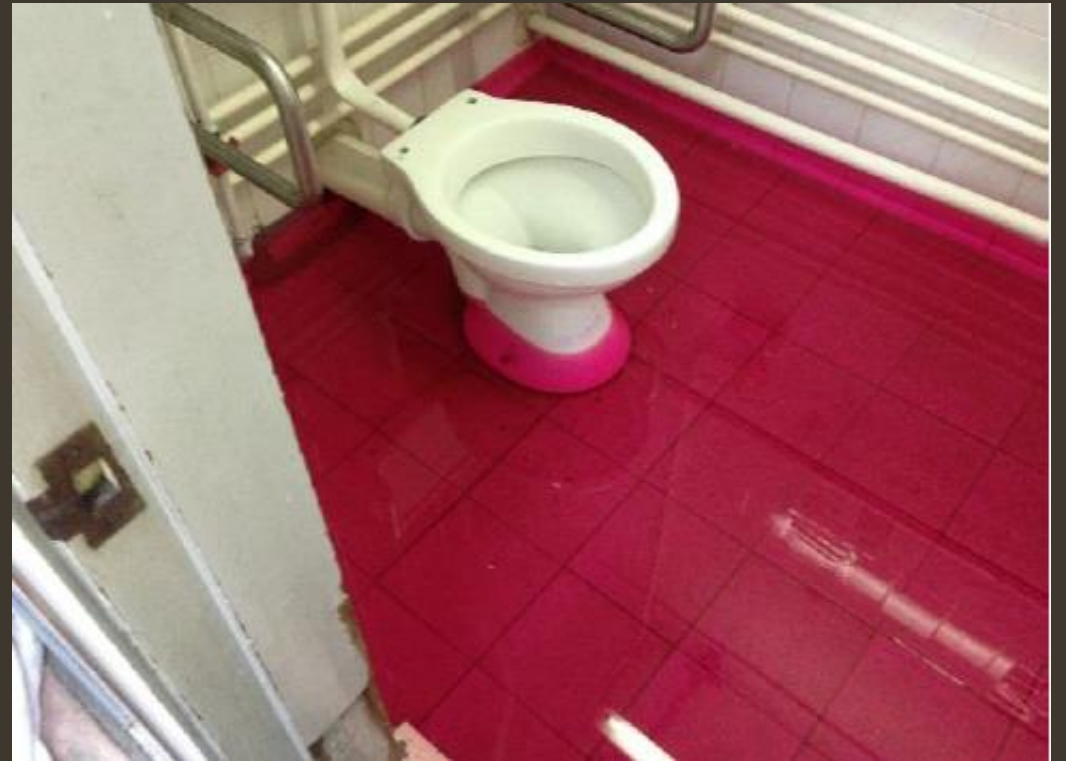
Ponding setup in DR1 & DR2 on 25 & 26/3/2015 and on 11/6/2015

Pond area in DR1 & DR2
around toilet bowl

Ponding setup on 2/4/2015 in DR1 & DR2

Pond area in DR1 (whole slab)

Pond area in DR2 (whole slab)

Date	25/3/2015	26/3/2015	2/4/2015
Pond Position	Around toilet bowl in DR1	Around toilet bowl in DR2	Whole slab of both DR1 & DR2
Pond Size	630mm x 520mm	650mm x 720mm	2300mmx1300mm
Ponding duration	1 hr	1.5 hrs	DR1: 2 hrs 38 mins DR2: 1 hr 22 mins
Time to 1 st drop of Water dripping	45 mins after ponding	50 mins after ponding	20 mins after 1 st ponding
