Building Surveyors Conference 2016:
Innovative Technologies in Building Surveying
Hong Kong Institute of Surveyors, 15 October 2016

Latest Research and Studies for Water Leakage Detection

Dr. Yu-Leuk CHOI

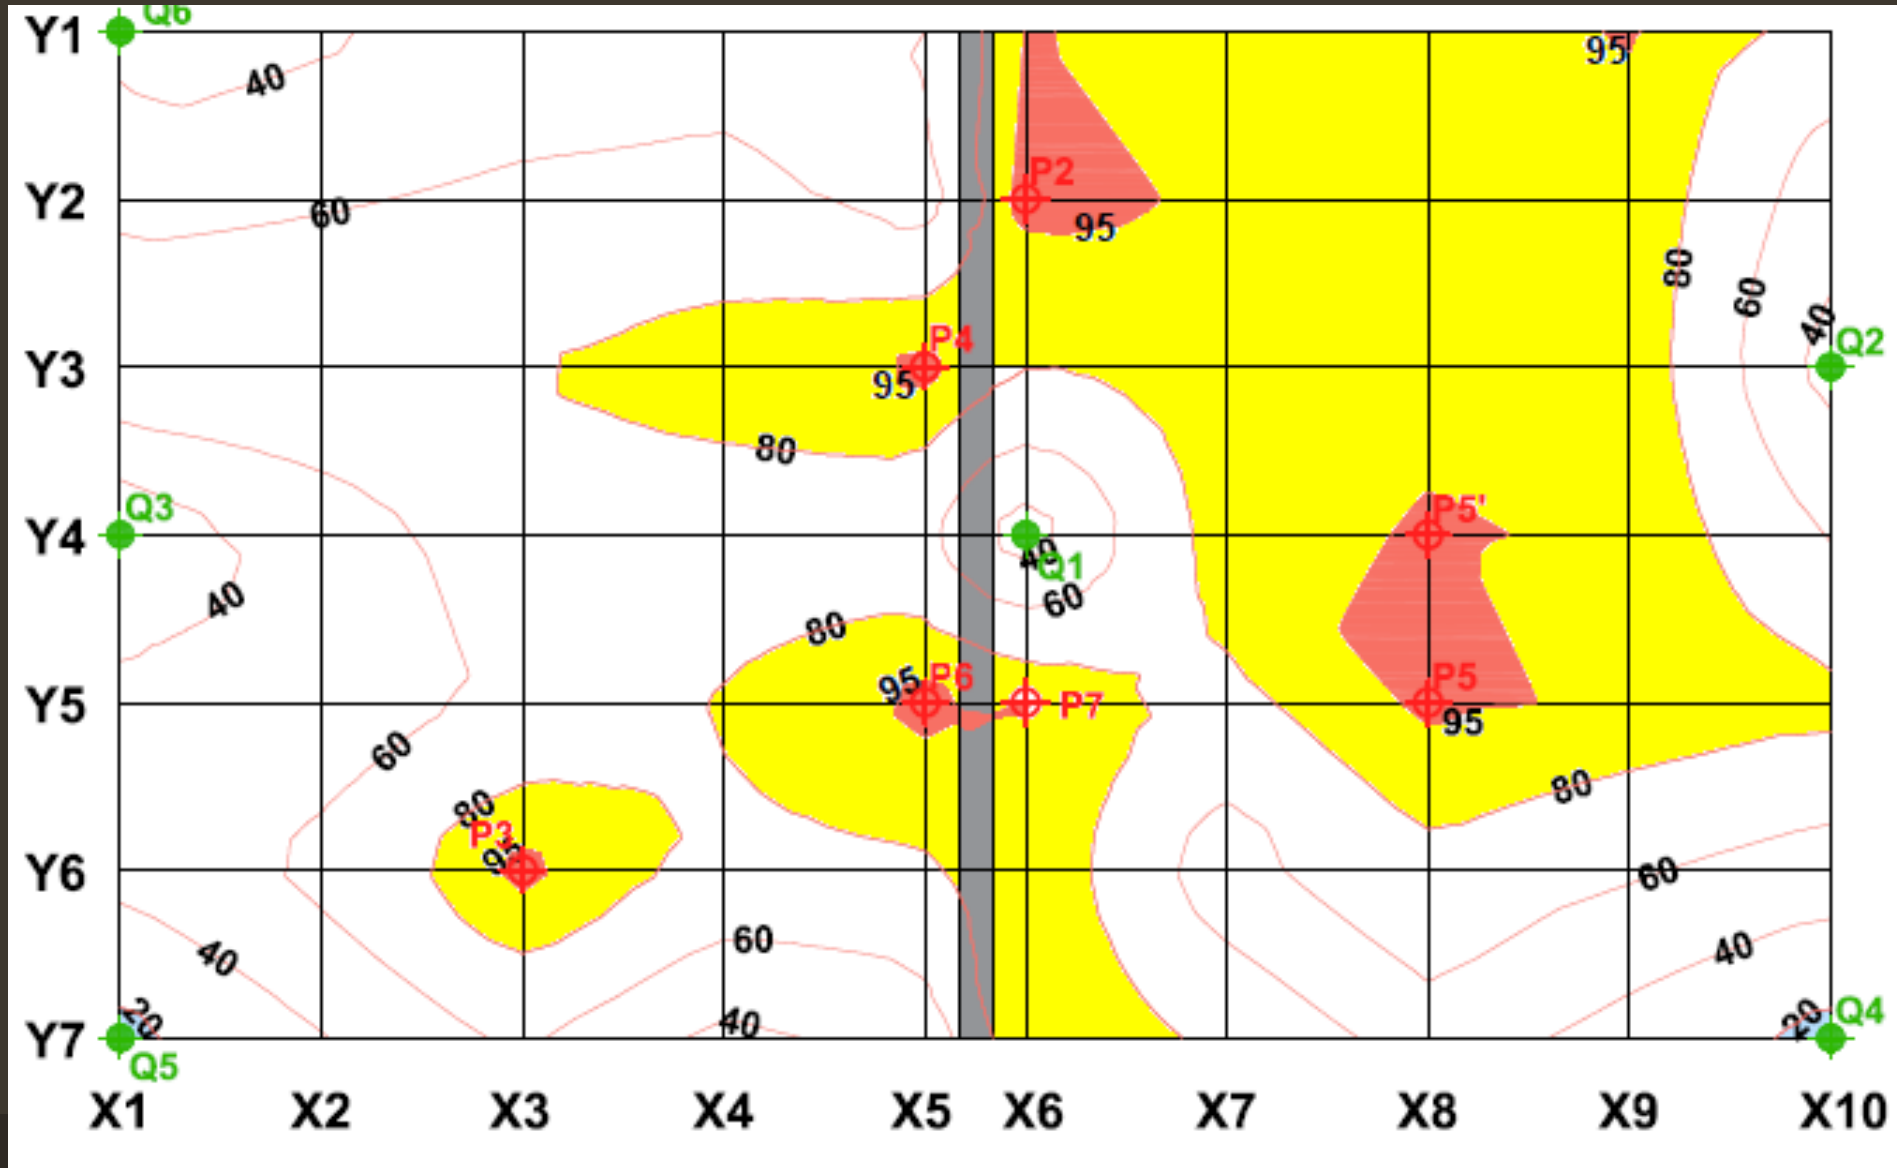
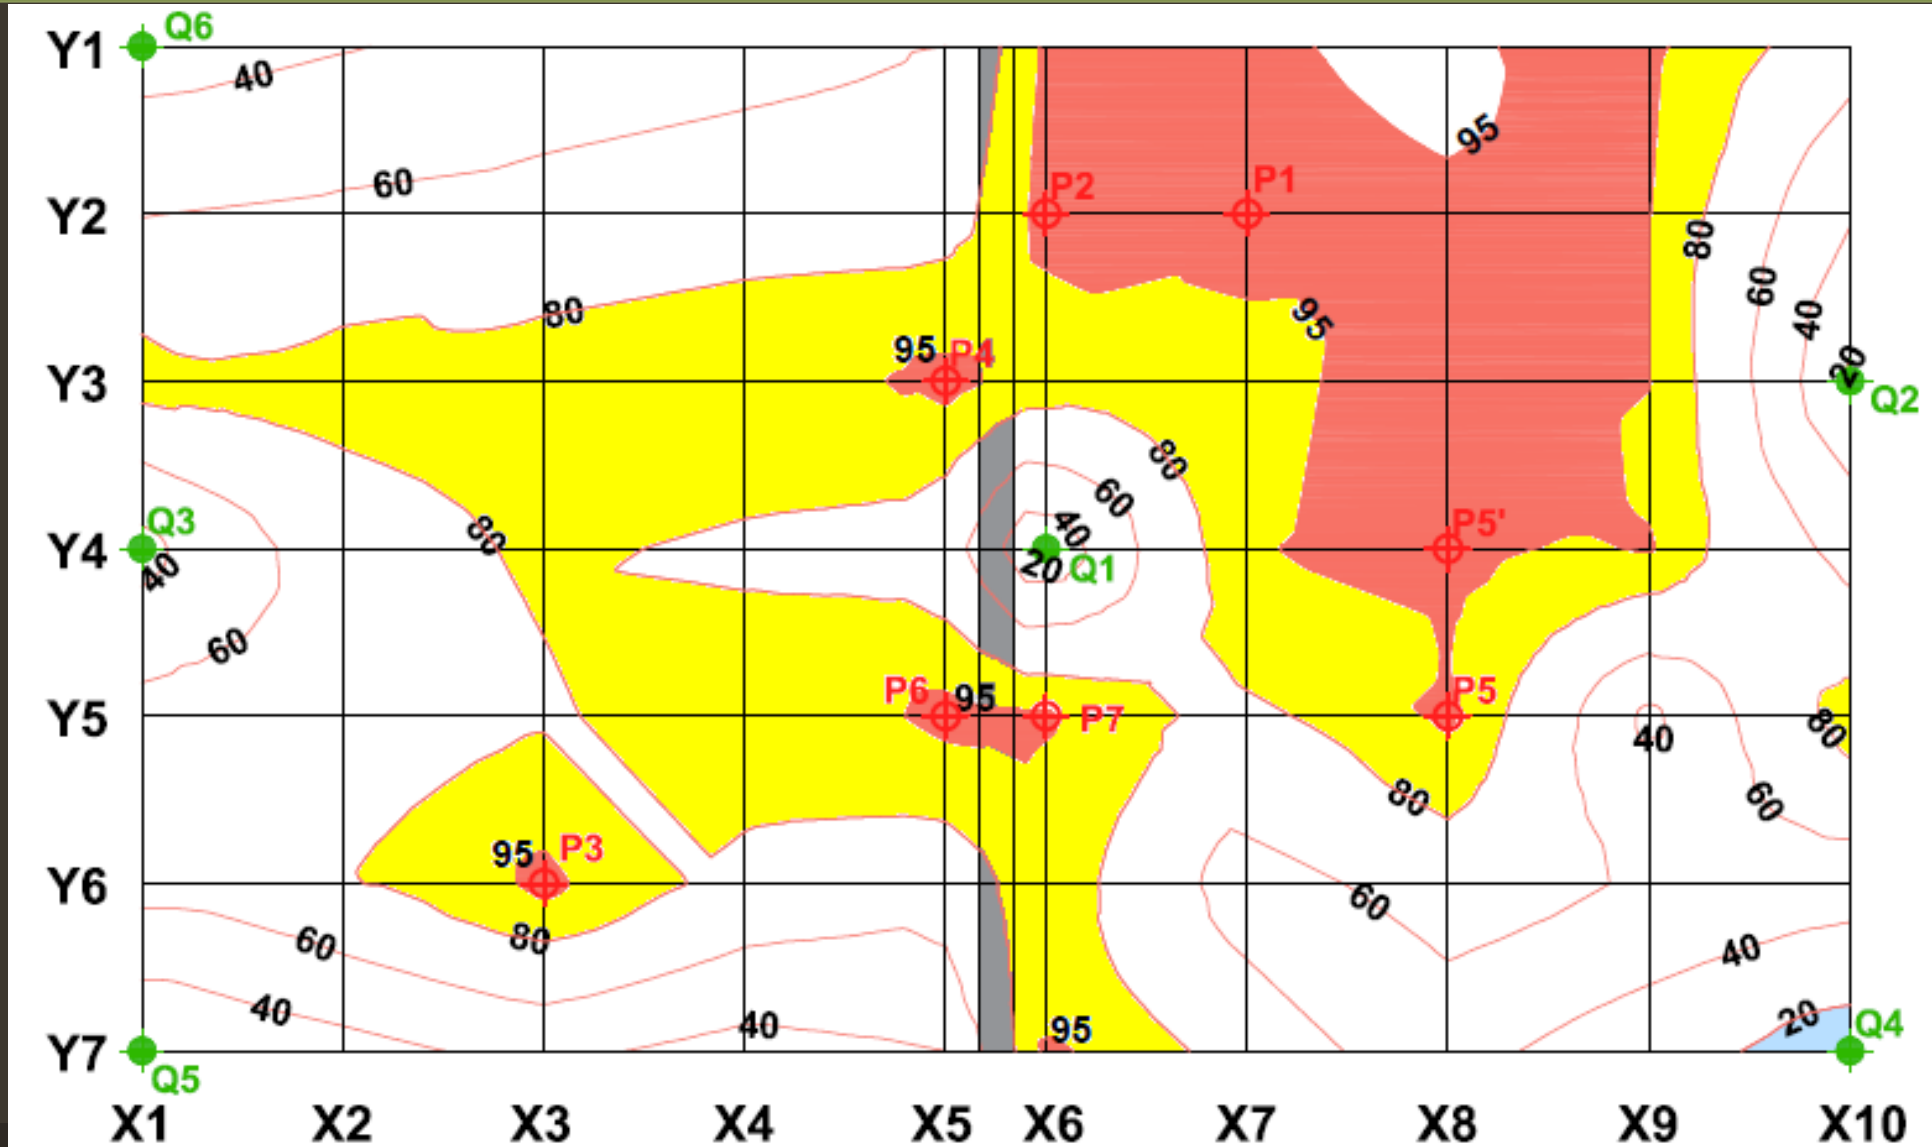
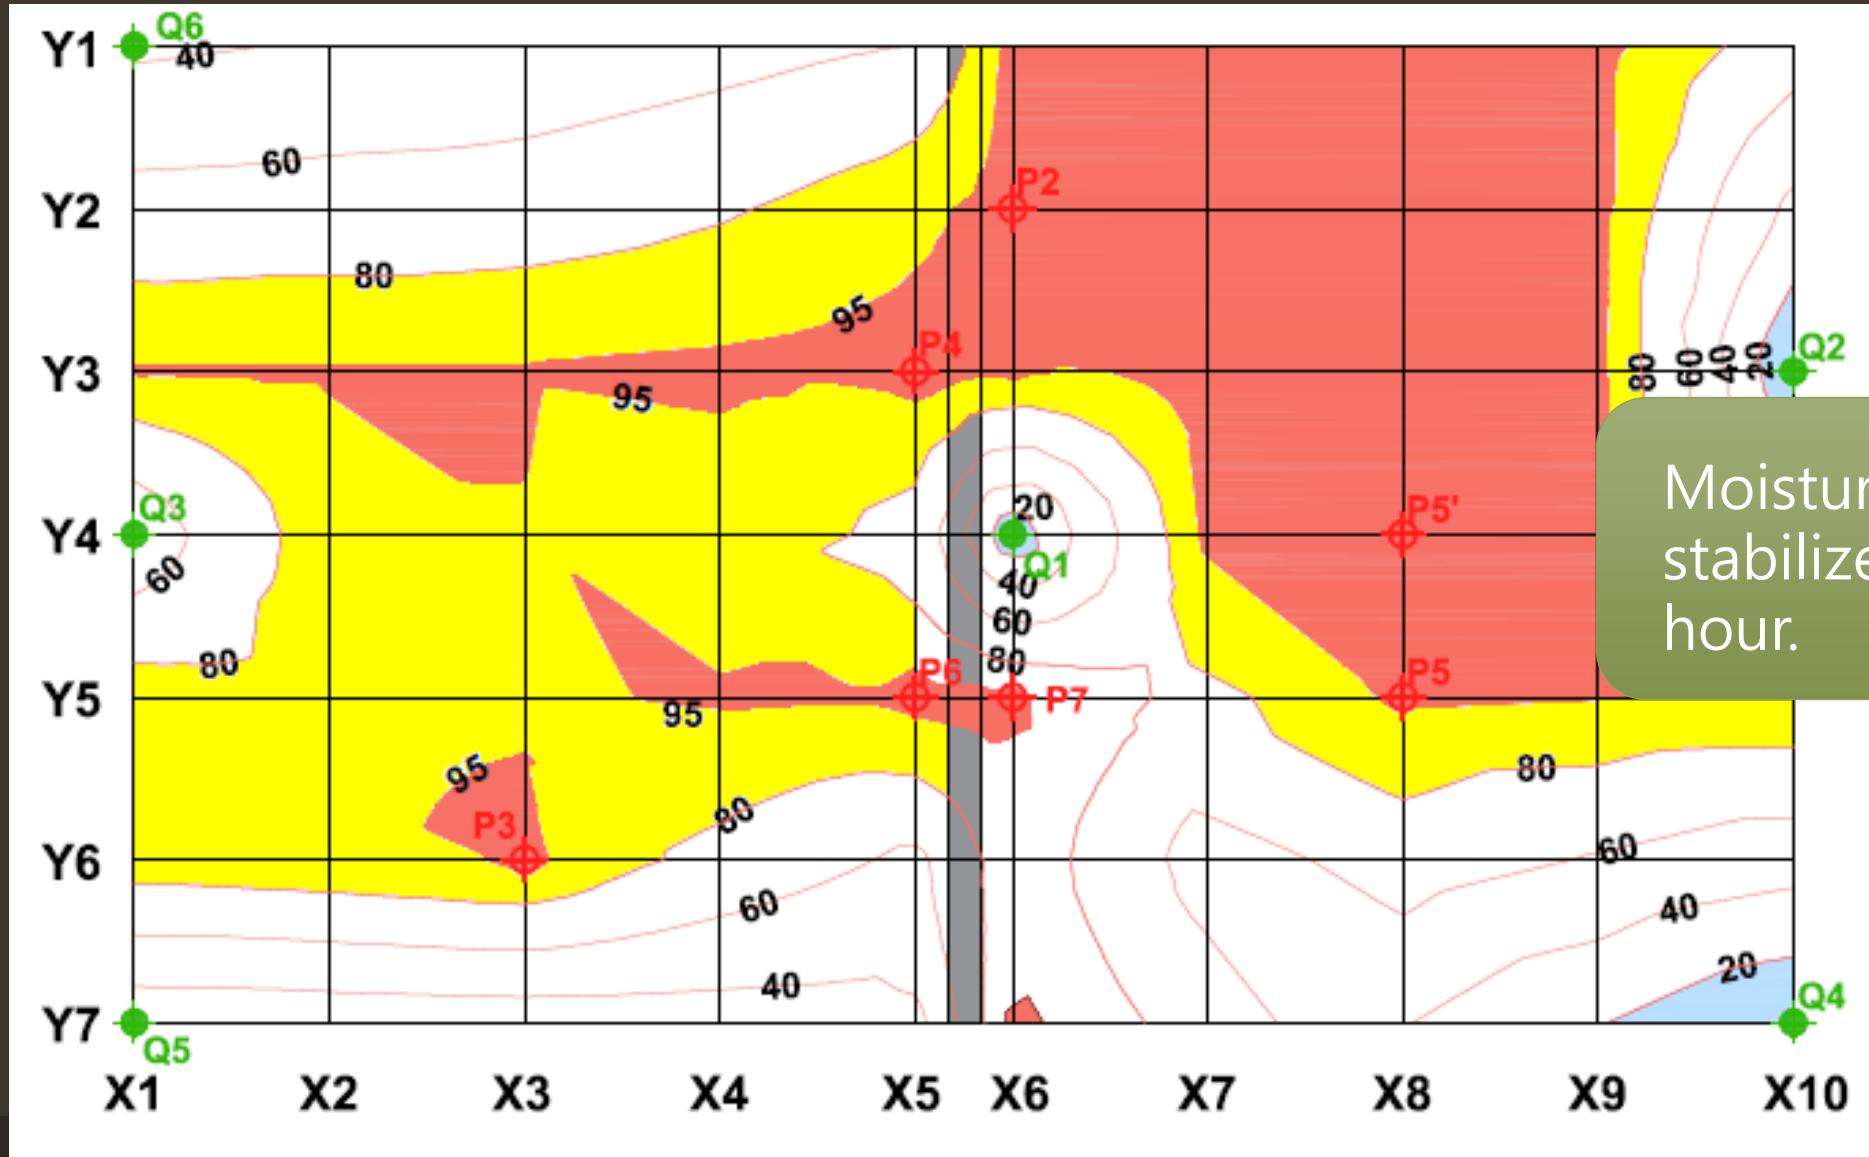
- Surface area of water table (WT) above dripping point >> cross-sectional area of dripping path. Hence 3-d inflow to dripping point. (Type 2 building seepage)
- Multiple paths of moisture flow to WT.
- Peaks and troughs in moisture contour map are potential inflow paths.
- Validated and amplified in subsequent ponding-scanning test on 11/6/2015.

Moisture Contours Map for $T_0 = 8:00\text{pm}$, DR1 & DR2, 11/6/2015

Moisture Contours Map for $T_1 = 8:30\text{pm}$, DR1 & DR2, 11/6/2015

Moisture Contours Map for $T_2 = 9:00\text{pm}$, DR1 & DR2, 11/6/2015

Moisture in DR2 stabilized in $1\frac{1}{2}$ hr

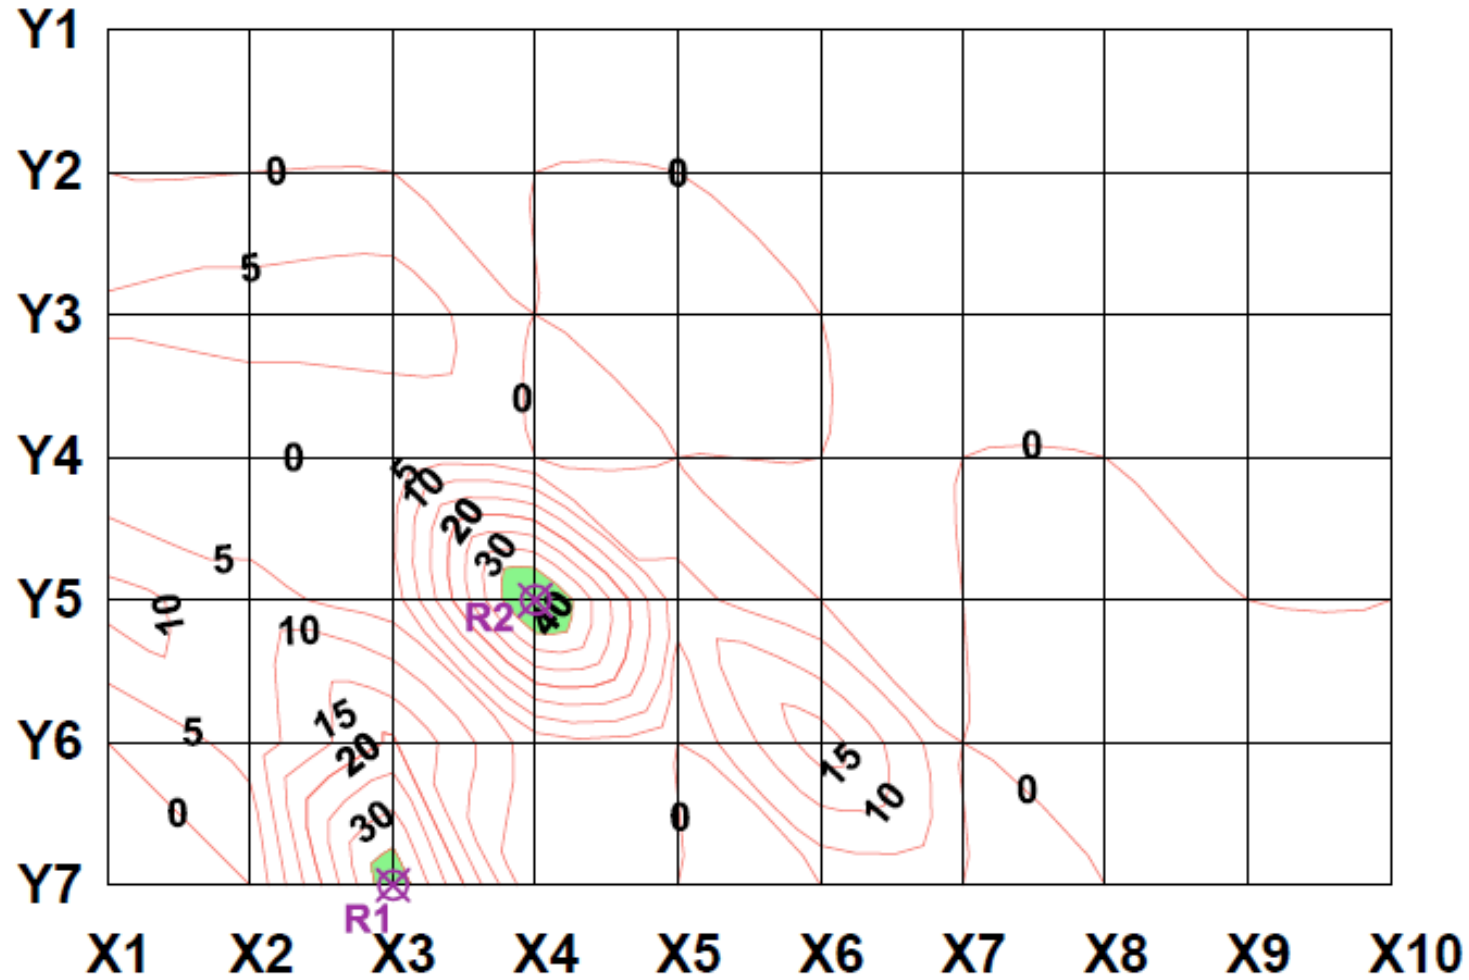
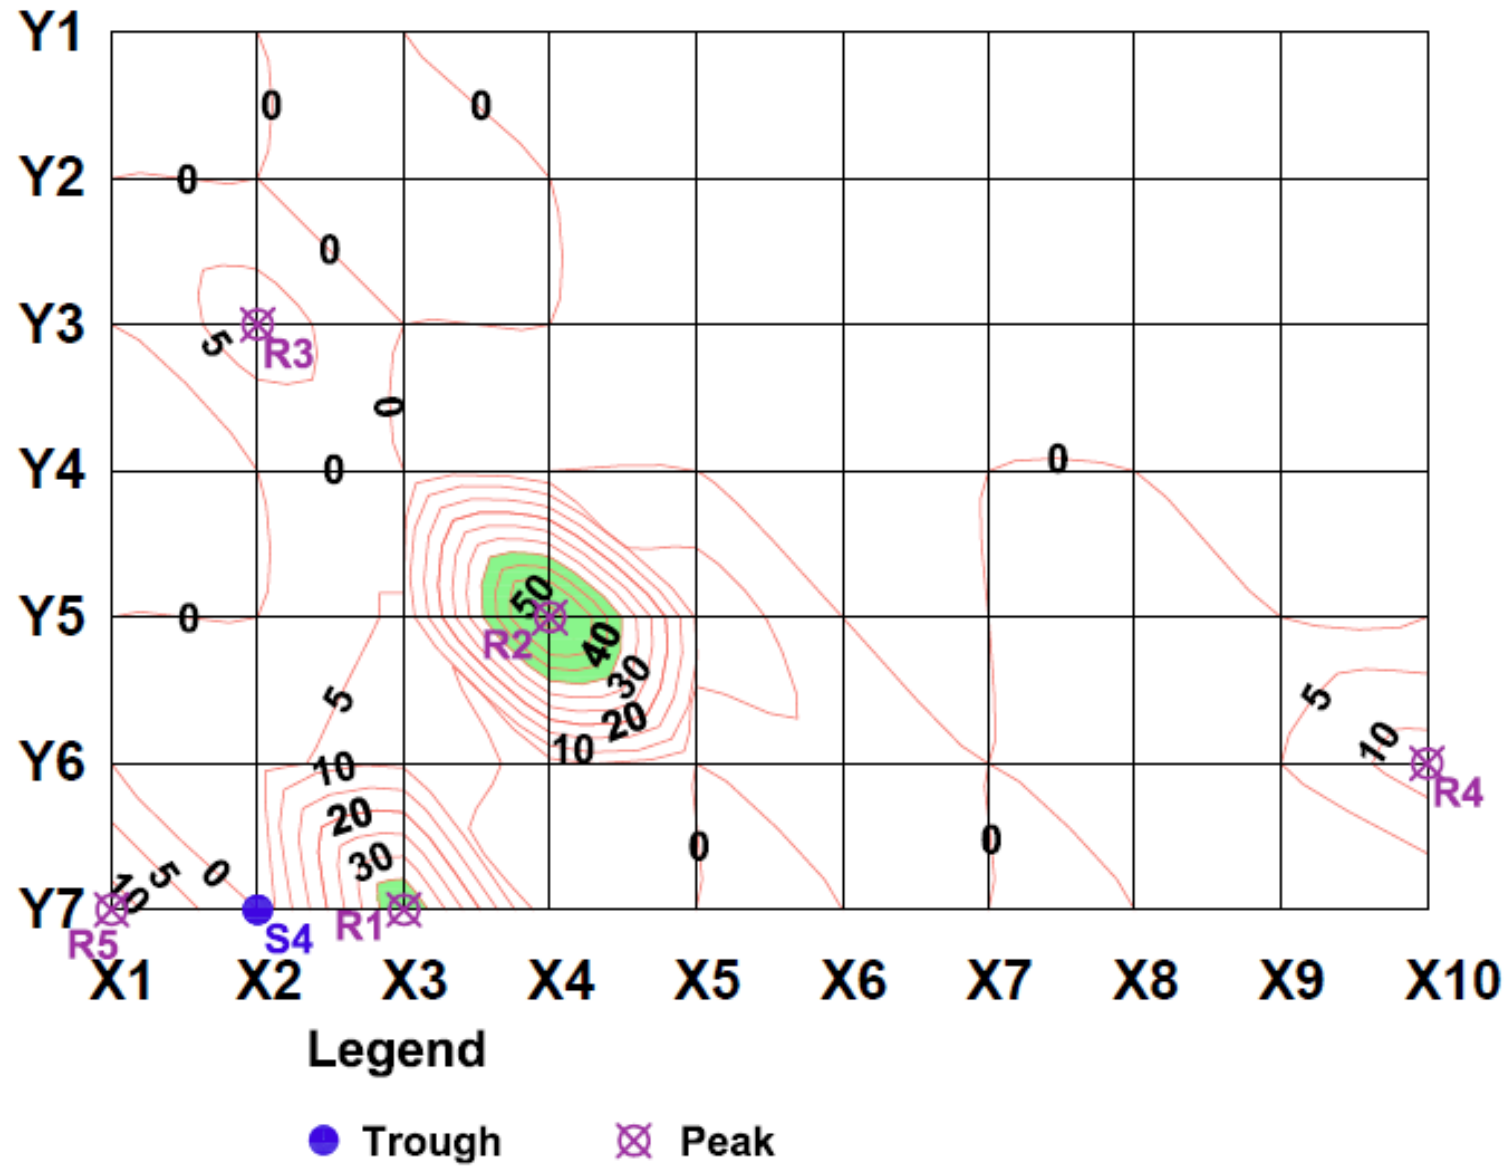
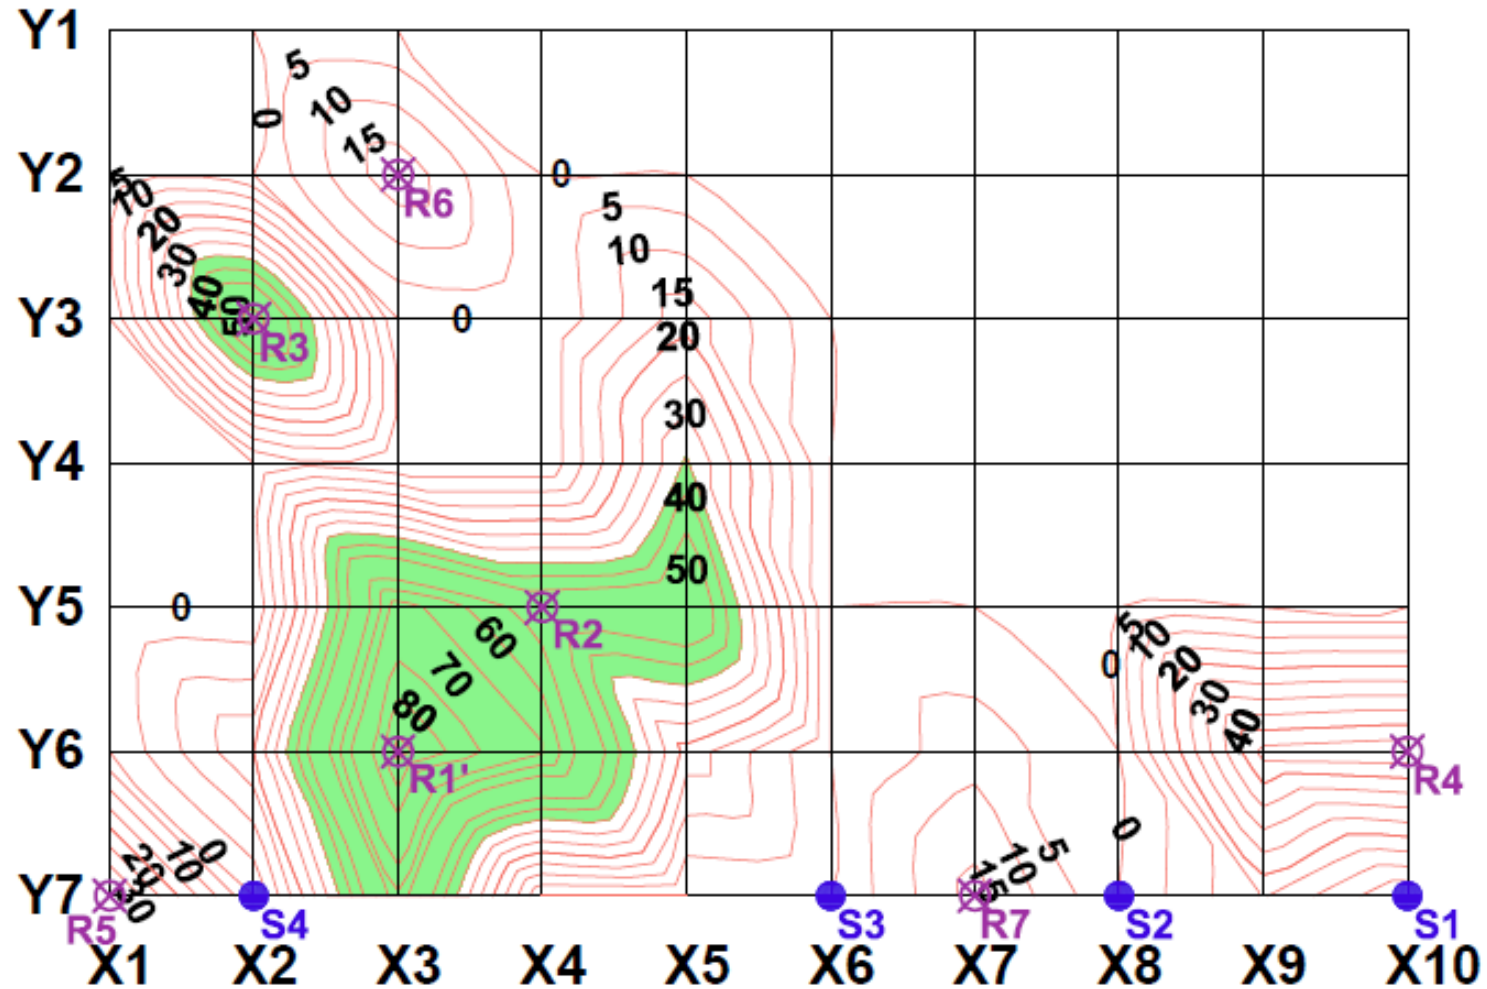
Moisture Contours Map for $T_0 = 8:00\text{pm}$, PT Room, 11/6/2015

Moisture Contours Map for $T_1 = 8:30\text{pm}$, PT oom, 11/6/2015

Moisture pattern stabilized in 1hr.

Moisture Contours Map for $T_3 = 9:30\text{pm}$, PT Room, 11/6/2015

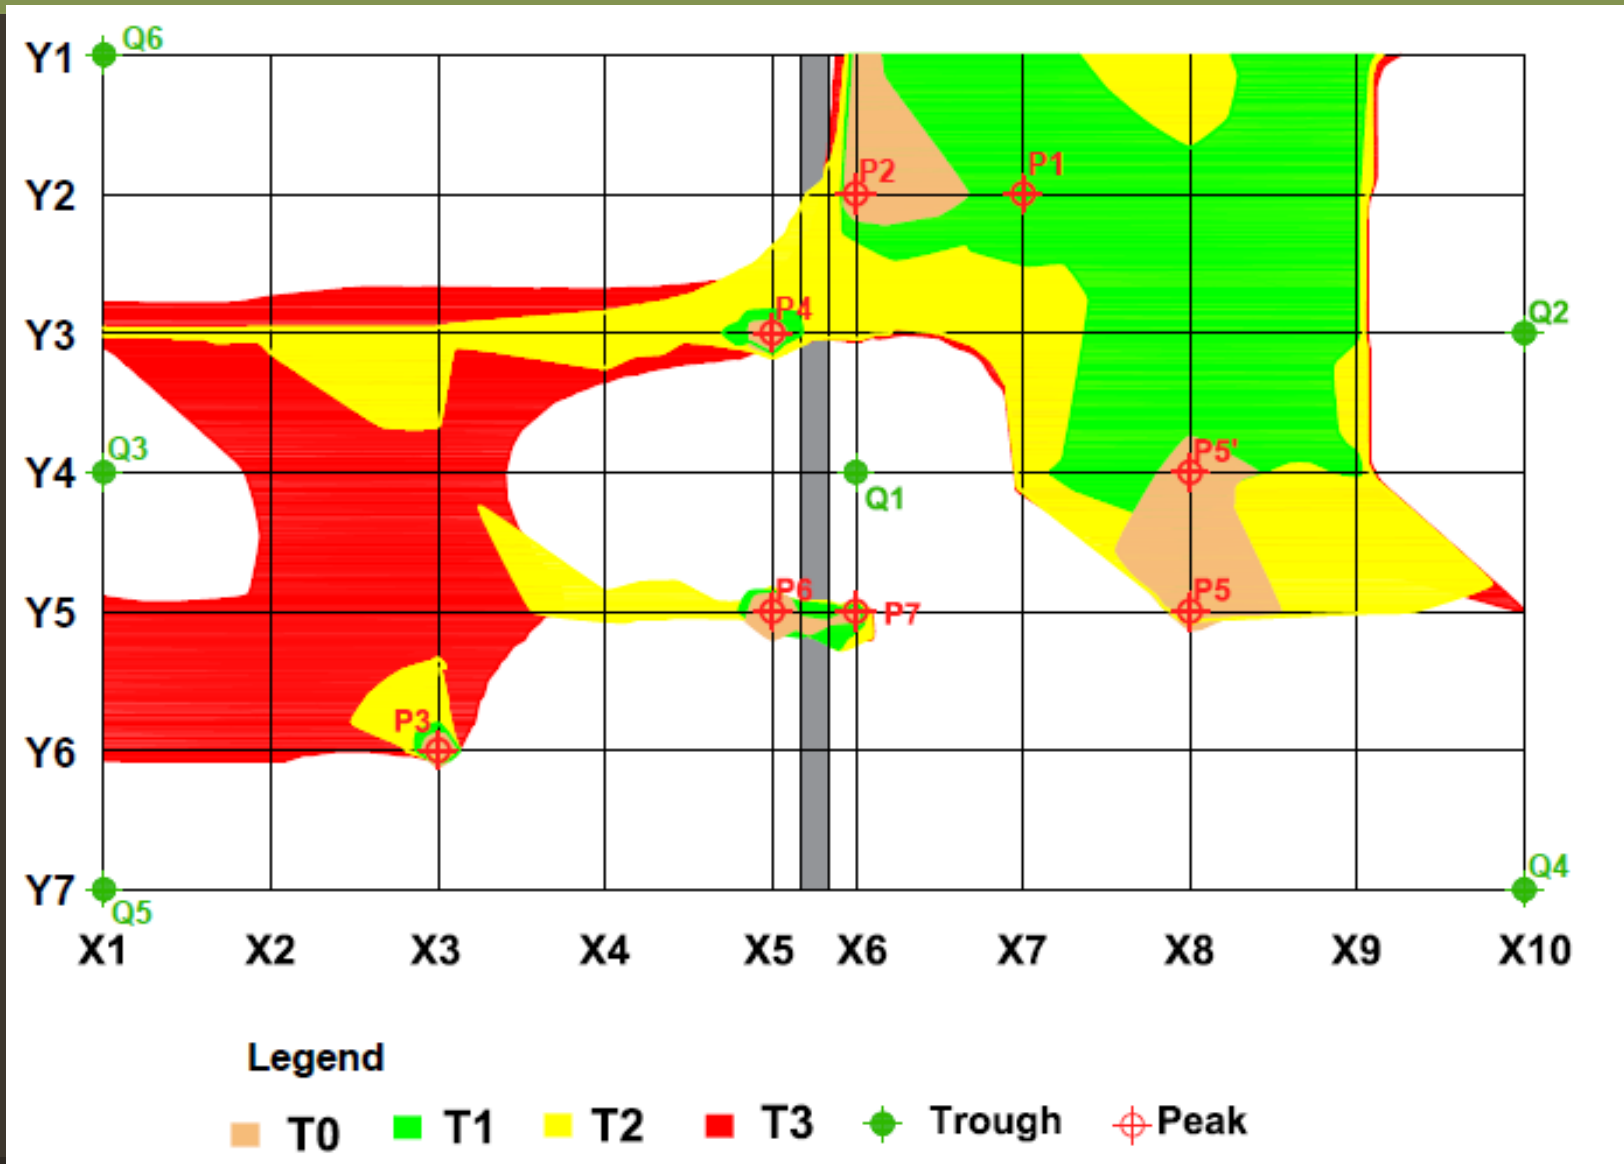
Peaks, Troughs & Propagation of 95-contours with time from DR scanning

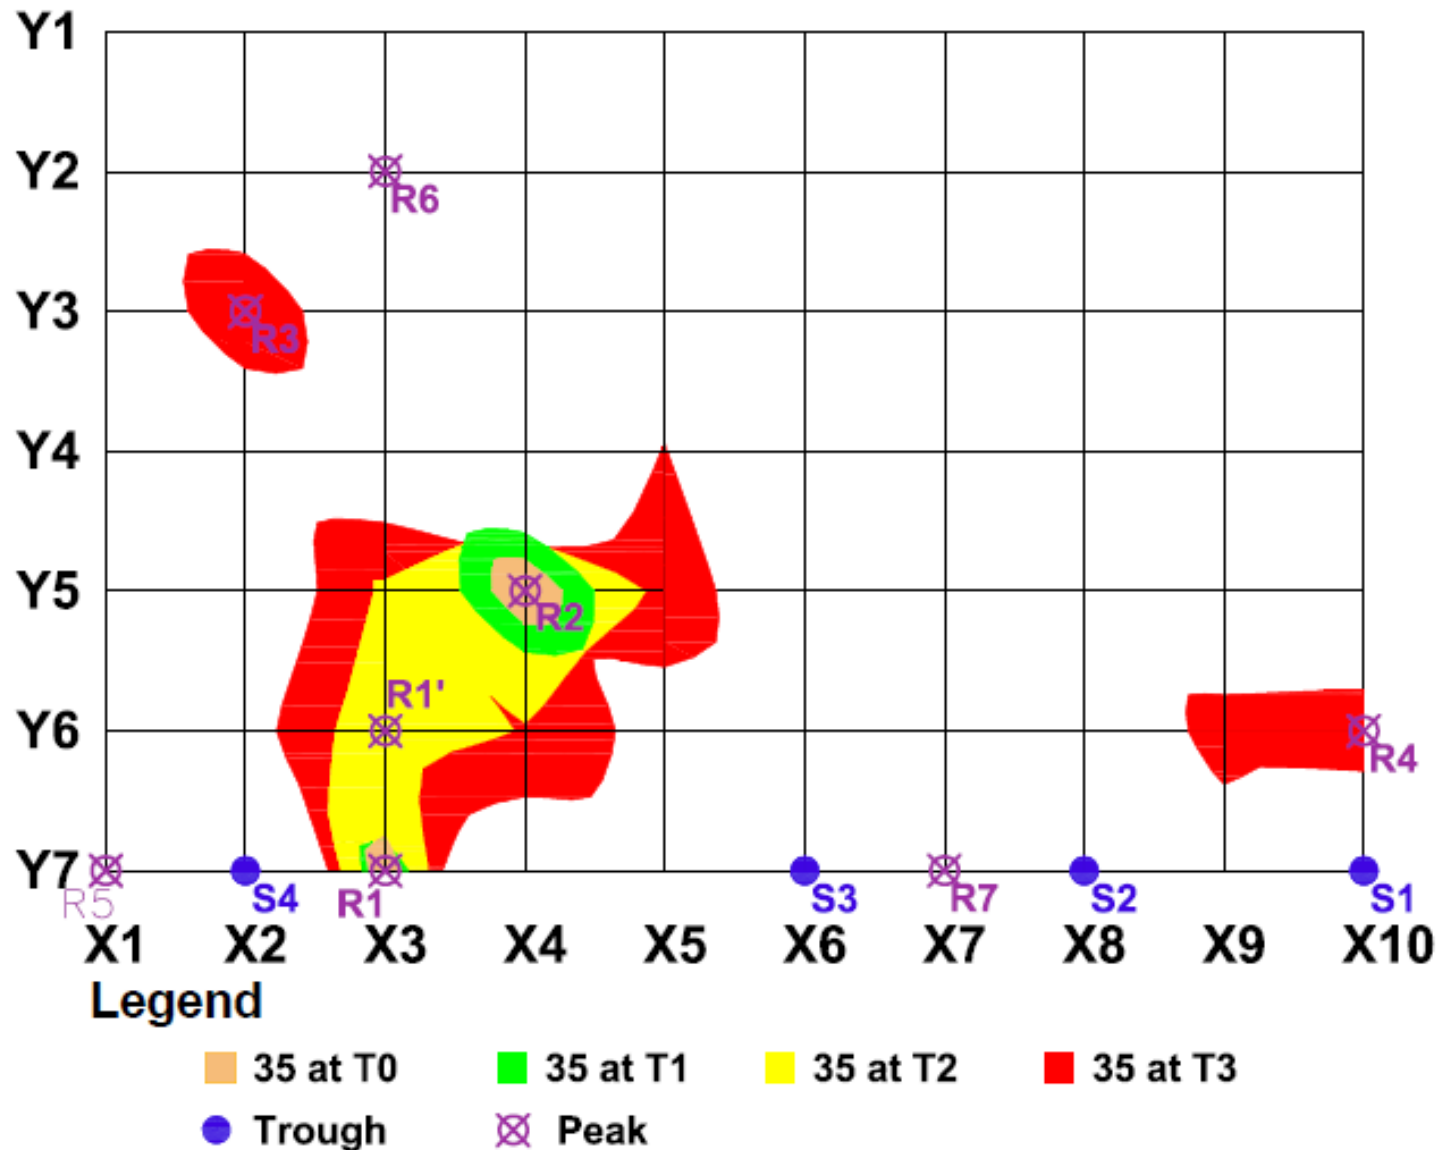
Peaks, Troughs & Propagation of 35-contours with time from PT Room scanning

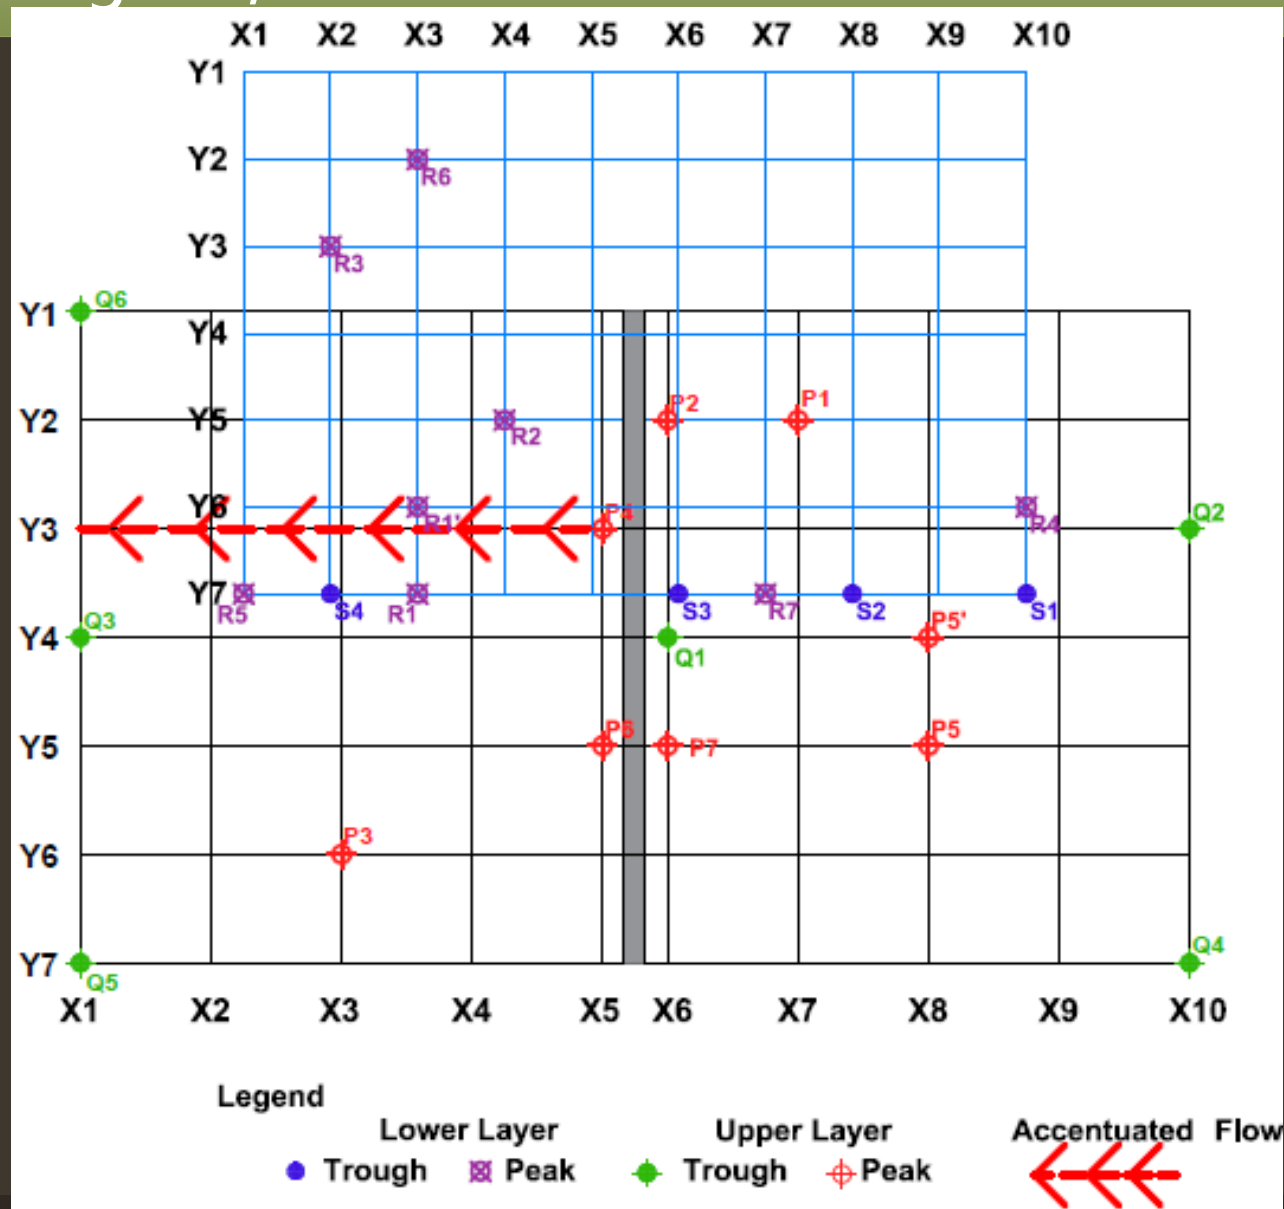
Potential Ingress, Exit & Accentuated Flow Path in RC Slab

- Flow field has 3 components:
 - A:** Accentuated Horizontal – vertical Flow in DR2,
 - B:** Accentuated vertical inflow scattered over DR1 & 2,
 - C:** Distributed infiltration (over most of DR Toilet floor)
- Permeability likely higher in upper layer of slab.

- Impermeability of surface layer of slab may have been impaired during alteration works for change of use of premises.
- Improving water tightness of tile binding layer may be more economical remedy to a mildly leaky floor slab.
